Access Compliance Report

Public Rights-of-Way

(Curb Ramps)

Intersection ID: 13838	Main Street: TOOMEY_AV	Cross Street: WILMORE_DR	Location: NW
ADA ID: BDEC7DFFFDCA	Ramp Type: PerpDiag	Initial Pass/Fail: Fail	Overall Compliance: No
		Severity Score: 25

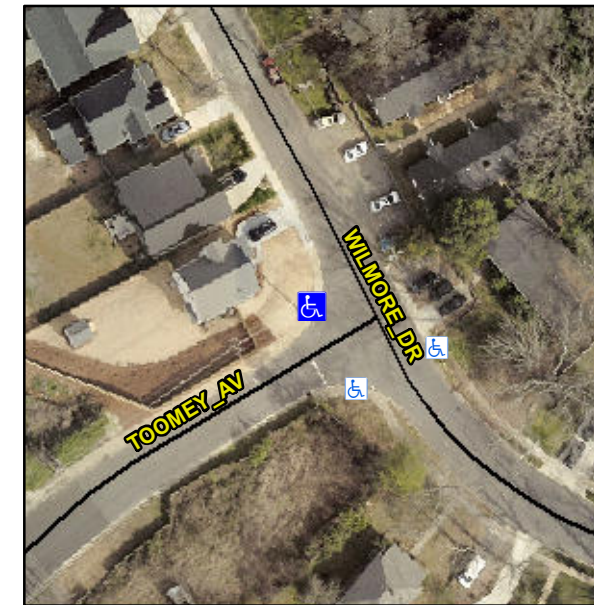
Compliance	Description	Data	Compliance	Description	Data
N/A	Ramp Length (in)	50.0	No	Ramp Slope (%)	8.5
Yes	Ramp Width (in)	48.0	No	Ramp XSlope (%)	6.5
N/A	Flare Type LT	N/A	N/A	Flare Type RT	N/A
N/A	Flare Slope LT (%)	N/A	N/A	Flare Slope RT (%)	N/A
N/A	Flare Traversable LT?	N/A	N/A	Flare Traversable RT?	N/A
N/A	Landing Length (in)	N/A	N/A	DWS Provided?	N/A
N/A	Landing Width (in)	N/A	N/A	DWS Contrast?	N/A
N/A	Landing Slope (%)	N/A	N/A	DWS Length (in)	N/A
N/A	Landing X Slope (%)	N/A	N/A	DWS Full Width?	N/A
N/A	Landing Curb? (Y/N)	N/A	N/A	DWS Offset (in)	N/A
N/A	Shared Landing?	N/A			
N/A	Gutter Ponding?	N/A	N/A	Gutter Slope (%)	N/A
N/A	Gutter Lip Ht (in)	N/A	N/A	Gutter X Slope (%)	N/A
N/A	Painted X Walk1?	No	N/A	Painted X Walk2?	No
	X Walk 1 Direction	To SE		X Walk 2 Direction	To E
N/A	X Walk 1 Width (in)	N/A	N/A	X Walk 2 Width (in)	N/A
	X Walk 1 Slope (%)	9.2		X Walk 2 Slope (%)	2.8
	X Walk 1 X Slope (%)	2.5		X Walk 2 X Slope (%)	9.4

N/A	Ramp inside XWalk1?	N/A	N/A	Ramp inside XWalk2?	N/A
	Road Slope (%)	4.5	N/A	Clear Space?	N/A
	Road X Slope (%)	11.1	N/A	Clear Space to XWalk (in)	N/A
N/A	Any Obstructions?	N/A	N/A	Storm Grate/Utility Hazard?	N/A
	Obstruction Type			Storm Grate/Utility Type	
		N/A			N/A
			Yes	Surface Condition? (G/P)	Good

Remove & Replace Curb Ramp With Two New Directional Ramps or Equivalent.
