Access Compliance Report Public Rights-of-Way (Curb Ramps)

Intersection ID: 4413 Main Street: CHASTAIN_PARC_DR Cross Street: WATTSDALE_AV Location: NE **Overall Compliance: No Severity Score: ADA ID: BDEF2BCDF216** Ramp Type: Perp Initial Pass/Fail: Fail 10

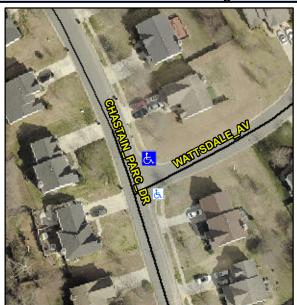
Field Measurements/Component Compliance								
Comp	liance Description	Data	Comp	liance	Description	Data		
N/A	Ramp Length (in)	43.5	Yes	Ramp	Slope (%)	5.3		
No	Ramp Width (in)	45.5	No	Ramp	XSlope (%)	4.6		
N/A	Flare Type LT	N/A	N/A	Flare	Type RT	N/A		
N/A	Flare Slope LT (%)	N/A	N/A	Flare	Slope RT (%)	N/A		
N/A	Flare Traversable LT?	N/A	N/A	Flare	Traversable RT?	N/A		
N/A	Landing Length (in)	N/A	N/A	DWS	Provided?	N/A		
N/A	Landing Width (in)	N/A	N/A	DWS	Contrast?	N/A		
N/A	Landing Slope (%)	N/A	N/A	DWS	Length (in)	N/A		
N/A	Landing X Slope (%)	N/A	N/A	DWS	Full Width?	N/A		
N/A	Landing Curb? (Y/N)	N/A	N/A	DWS	Offset (in)	N/A		
N/A	Shared Landing?	N/A						
N/A	Gutter Ponding?	N/A	N/A	Gutte	r Slope (%)	N/A		
N/A	Gutter Lip Ht (in)	N/A	N/A	Gutte	r X Slope (%)	N/A		
N/A	Painted X Walk1?	No	N/A	Paint	ed X Walk2?	N/A		
	X Walk 1 Direction	To SE		X Wa	lk 2 Direction	N/A		
N/A	X Walk 1 Width (in)	N/A	N/A	X Wa	lk 2 Width (in)	N/A

X Walk 1 Slope (%)	3.5		X Wa	lk 2 Slope (%)	N/A		
	X Walk 1 X Slope (%)	5.0		X Wa	lk 2 X Slope (%)	N/A		
N/A	Ramp inside XWalk1?	N/A	N/A	Ram	inside XWalk2?	N/A		
	Road Slope (%)	N/A	N/A	Clear	Space?	N/A		
	Road X Slope (%)	N/A	N/A	Clear	Space to XWalk (in)	N/A		
N/A	Any Obstructions?	N/A	N/A	Storn	n Grate/Utility Hazard?	N/A		
	Obstruction Type			Storn	n Grate/Utility Type			
		N/A				N/A		
			Yes	Surfa	ce Condition? (G/P)	Good

Possible Solutions:	<u>c</u>	
Remove & Replace Entire Ramp.		
	N	
	N	
	N	
	N	
	N	
Surveyor Notes:	N	
N/A	N	
	N	
	N	
	N	
PROW/ADA:	N	
Not Found, R304.5.1, R304.5.3	N	
	N	
	N	
	N
