# Access Compliance Report

## Public Rights-of-Way

### (Curb Ramps)

Intersection ID: 10040562	Main Street: W_9TH_ST	Cross Street: N/A	Location: S
ADA ID: BDF12601CE41	Ramp Type: Perp	Initial Pass/Fail: Fail	Overall Compliance: No
Severity Score: 37.5			
Codes/Mitigation Info/Possible Solution		Field Measurements/Component Compliance

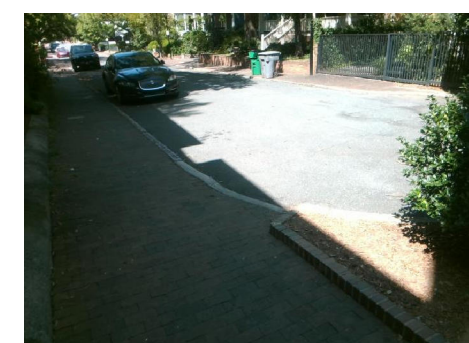
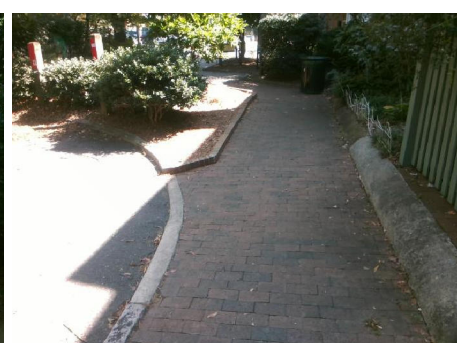
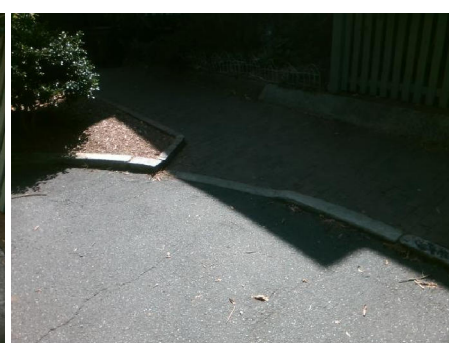
**Not Found, R304.2.2, R304.5.3**

Compliance	Description	Data	Compliance	Description	Data
N/A	Ramp Length (in)	62.0	No	Ramp Slope (%)	10.5
Yes	Ramp Width (in)	50.0	No	Ramp XSlope (%)	9.6
N/A	Flare Type LT	N/A	N/A	Flare Type RT	N/A
N/A	Flare Slope LT (%)	N/A	N/A	Flare Slope RT (%)	N/A
N/A	Flare Traversable LT?	N/A	N/A	Flare Traversable RT?	N/A
N/A	Landing Length (in)	N/A	N/A	DWS Provided?	N/A
N/A	Landing Width (in)	N/A	N/A	DWS Contrast?	N/A
N/A	Landing Slope (%)	N/A	N/A	DWS Length (in)	N/A
N/A	Landing X Slope (%)	N/A	N/A	DWS Full Width?	N/A
N/A	Landing Curb? (Y/N)	N/A	N/A	DWS Offset (in)	N/A
N/A	Shared Landing?	N/A			
N/A	Gutter Ponding?	N/A	N/A	Gutter Slope (%)	N/A
N/A	Gutter Lip Ht (in)	N/A	N/A	Gutter X Slope (%)	N/A
N/A	Painted X Walk1?	No	N/A	Painted X Walk2?	N/A
	X Walk 1 Direction	To N		X Walk 2 Direction	N/A
N/A	X Walk 1 Width (in)	N/A	N/A	X Walk 2 Width (in)	N/A
	X Walk 1 Slope (%)	3.1		X Walk 2 Slope (%)	N/A
	X Walk 1 X Slope (%)	1.6		X Walk 2 X Slope (%)	N/A

N/A	Ramp inside XWalk1?	N/A	N/A	Ramp inside XWalk2?	N/A
	Road Slope (%)	N/A	N/A	Clear Space?	N/A
	Road X Slope (%)	N/A	N/A	Clear Space to XWalk (in)	N/A
N/A	Any Obstructions?	N/A	N/A	Storm Grate/Utility Hazard?	N/A
	Obstruction Type			Storm Grate/Utility Type	
		N/A			N/A
			Yes	Surface Condition? (G/P)	Good

**Remove & Replace Entire Ramp.**

Total Cost: \$ 1850.00
