# Access Compliance Report

## Public Rights-of-Way

### (Curb Ramps)

| Intersection ID: 44950 | Main Street: WEAVERS_GLENN_PL | Cross Street: OLDCORN_LN | Location: | S |

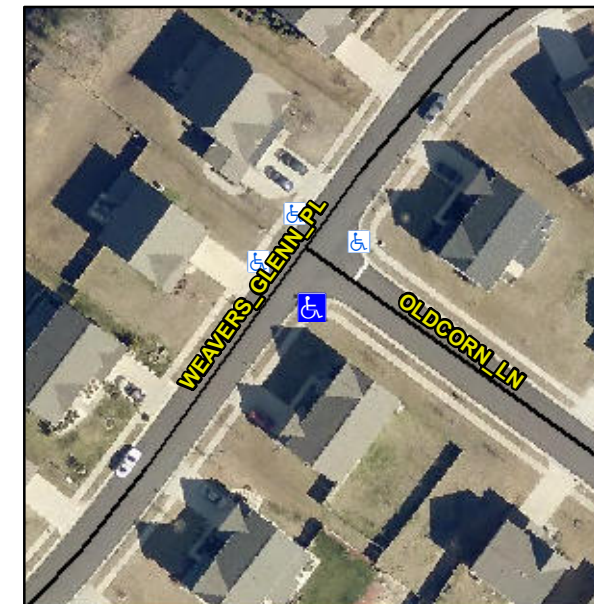
| ADA ID: BDF5E88F71FA | Ramp Type: PerpDiag | Initial Pass/Fail: Fail | Overall Compliance: No | Severity Score: 22.5 |

**Not Found, R304.5.1, R304.2.2, R304.5.3**

| Compliance | Description | Data | Compliance | Description | Data |
|---|---|---|---|---|---|
| N/A | Ramp Length (in) | 47.0 | No | Ramp Slope (%) | 8.5 |
| No | Ramp Width (in) | 47.5 | No | Ramp XSlope (%) | 4.6 |

**Remove & Replace Curb Ramp With Two New Directional Ramps or Equivalent.**

Total Cost: \$ 3200.00
