Access Compliance Report

Public Rights-of-Way

(Curb Ramps)

Intersection ID: 21717	Main Street: SARDIS_RD	Cross Street: WILBY_DR	Location: W
ADA ID: BE09E9A8777D	Ramp Type: PerpDiag	Initial Pass/Fail: Fail	Overall Compliance: No
			Severity Score: 21.25

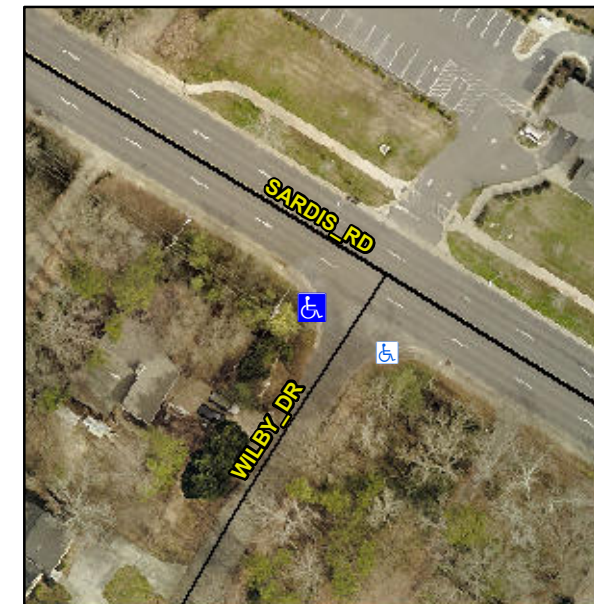
Not Found, R304.5.1, R304.2.2

Compliance	Description	Data	Compliance	Description	Data
N/A	Ramp Length (in)	59.0	No	Ramp Slope (%)	8.6
No	Ramp Width (in)	40.0	Yes	Ramp XSlope (%)	1.6
N/A	Flare Type LT	N/A	N/A	Flare Type RT	N/A
N/A	Flare Slope LT (%)	N/A	N/A	Flare Slope RT (%)	N/A
N/A	Flare Traversable LT?	N/A	N/A	Flare Traversable RT?	N/A
N/A	Landing Length (in)	N/A	N/A	DWS Provided?	N/A
N/A	Landing Width (in)	N/A	N/A	DWS Contrast?	N/A
N/A	Landing Slope (%)	N/A	N/A	DWS Length (in)	N/A
N/A	Landing X Slope (%)	N/A	N/A	DWS Full Width?	N/A
N/A	Landing Curb? (Y/N)	N/A	N/A	DWS Offset (in)	N/A
N/A	Shared Landing?	N/A			
N/A	Gutter Ponding?	N/A	N/A	Gutter Slope (%)	N/A
N/A	Gutter Lip Ht (in)	N/A	N/A	Gutter X Slope (%)	N/A
N/A	Painted X Walk1?	No	N/A	Painted X Walk2?	No
	X Walk 1 Direction	To SE		X Walk 2 Direction	To NE
N/A	X Walk 1 Width (in)	N/A	N/A	X Walk 2 Width (in)	N/A
	X Walk 1 Slope (%)	0.9		X Walk 2 Slope (%)	5.7
	X Walk 1 X Slope (%)	2.4		X Walk 2 X Slope (%)	0.5

N/A	Ramp inside XWalk1?	N/A	N/A	Ramp inside XWalk2?	N/A
	Road Slope (%)	0.7	N/A	Clear Space?	N/A
	Road X Slope (%)	3.4	N/A	Clear Space to XWalk (in)	N/A
N/A	Any Obstructions?	N/A	N/A	Storm Grate/Utility Hazard?	N/A
	Obstruction Type			Storm Grate/Utility Type	
		N/A			N/A
			Yes	Surface Condition? (G/P)	Good

Remove & Replace Curb Ramp With Two New Directional Ramps or Equivalent.

Total Cost: \$ 3200.00
