Access Compliance Report

Public Rights-of-Way

(Curb Ramps)

Intersection ID: N/A	Main Street: LITTLE ROCK RD	Cross Street: N/A	Location: N
ADA ID: BE0F563D0A85	Ramp Type: Para	Initial Pass/Fail: Pass	Overall Compliance: No
		Severity Score: 0

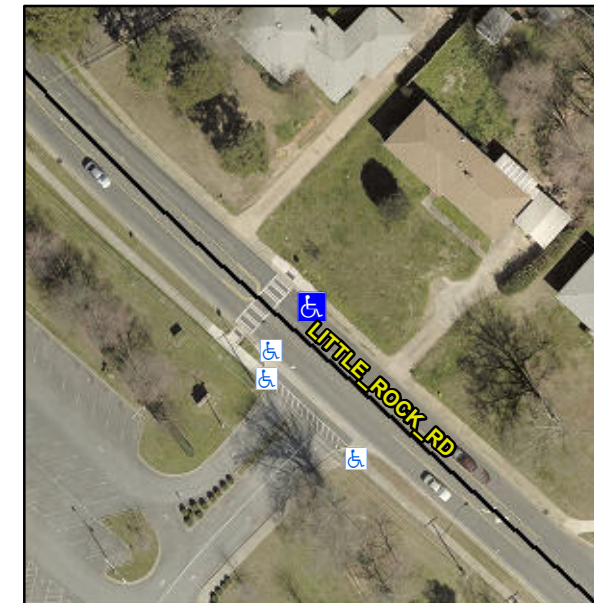
Compliance	Description	Data	Compliance	Description	Data
N/A	Ramp Length LT (in)	54.0	N/A	Ramp Length RT (in)	61.0
Yes	Ramp Width LT (in)	59.0	Yes	Ramp Width RT (in)	57.0
Yes	Ramp Slope LT (%)	5.2	Yes	Ramp Slope RT (%)	6.0
Yes	Ramp XSlope LT (%)	0.9	Yes	Ramp XSlope RT (%)	1.0
No	Landing Length (in)	57.0	Yes	DWS Provided?	Yes
Yes	Landing Width (in)	60.0	Yes	DWS Contrast?	Yes
Yes	Landing Slope (%)	1.2	Yes	DWS Length (in)	24.0
No	Landing X Slope (%)	4.4	Yes	DWS Full Width?	Yes
N/A	Landing Curb? (Y/N)	Yes	No	DWS Offset (in)	2.5
N/A	Shared Landing?	No			
Yes	Gutter Ponding?	No	Yes	Gutter Slope (%)	0.1
Yes	Gutter Lip Ht (in)	0.0	Yes	Gutter X Slope (%)	2.7
N/A	Painted X Walk1?	Yes	N/A	Painted X Walk2?	N/A
	X Walk 1 Direction	To SW		X Walk 2 Direction	N/A
N/A	X Walk 1 Width (in)	114.0	N/A	X Walk 2 Width (in)	N/A
	X Walk 1 Slope (%)	1.7		X Walk 2 Slope (%)	N/A
	X Walk 1 X Slope (%)	3.0		X Walk 2 X Slope (%)	N/A
Yes	Ramp inside XWalk1?	Yes	N/A	Ramp inside XWalk2?	N/A

Road Slope (%)	N/A	N/A	Clear Space?	Yes
	Road X Slope (%)	N/A	N/A	Clear Space to XWalk (in)	N/A
Yes	Any Obstructions?	No	Yes	Storm Grate/Utility Hazard?	No
	Obstruction Type			Storm Grate/Utility Type	
		N/A			N/A
			Yes	Surface Condition? (G/P)	Good
			Compliant	Curb Slope (%)	2.4

Remove & Replace Entire Ramp.
