Access Compliance Report

Public Rights-of-Way

(Curb Ramps)

Intersection ID: 46810	Main Street: ARBOR_VISTA_DR	Cross Street: CLAUDE_FREEMAN_DR	Location: E
ADA ID: BE1AA4FCC3E4	Ramp Type: Combination1	Initial Pass/Fail: Fail	Overall Compliance: No
			Severity Score: 33.75

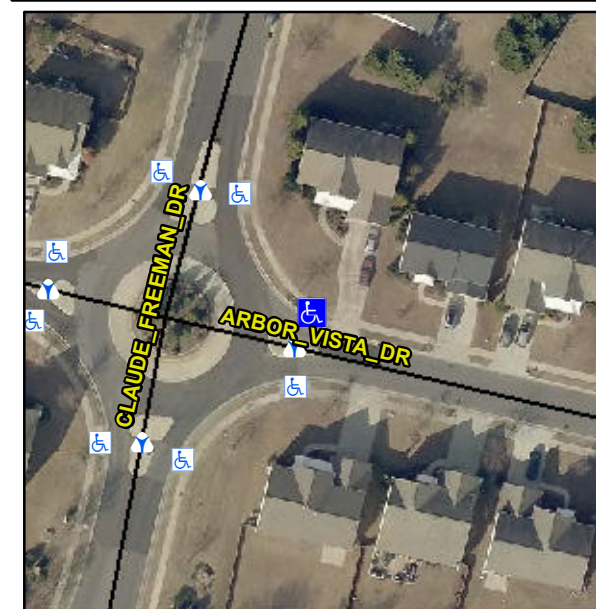
Compliance	Description	Data	Compliance	Description	Data
N/A	Ramp Length LT (in)	72.5	N/A	Ramp Length RT (in)	63.0
No	Ramp Width LT (in)	46.5	Yes	Ramp Width RT (in)	48.0
Yes	Ramp Slope LT (%)	7.2	Yes	Ramp Slope RT (%)	5.2
Yes	Ramp XSlope LT (%)	1.7	Yes	Ramp XSlope RT (%)	1.7
N/A	Ramp Length (in)	44.0	No	Ramp Slope (%)	12.5
Yes	Ramp Width (in)	63.0	Yes	Ramp XSlope (%)	0.3
N/A	Flare Type LT	N/A	N/A	Flare Type RT	N/A
N/A	Flare Slope LT (%)	N/A	N/A	Flare Slope RT (%)	N/A
N/A	Flare Traversable LT?	N/A	N/A	Flare Traversable RT?	N/A
N/A	Landing Length (in)	N/A	N/A	DWS Provided?	N/A
N/A	Landing Width (in)	N/A	N/A	DWS Contrast?	N/A
N/A	Landing Slope (%)	N/A	N/A	DWS Length (in)	N/A
N/A	Landing X Slope (%)	N/A	N/A	DWS Full Width?	N/A
N/A	Landing Curb? (Y/N)	N/A	N/A	DWS Offset (in)	N/A
N/A	Shared Landing?	N/A			
N/A	Gutter Ponding?	N/A	N/A	Gutter Slope (%)	N/A
N/A	Gutter Lip Ht (in)	N/A	N/A	Gutter X Slope (%)	N/A
N/A	Painted X Walk1?	No	N/A	Painted X Walk2?	N/A

X Walk 1 Direction	To S		X Walk 2 Direction	N/A
	X Walk 1 Width (in)	N/A		X Walk 2 Width (in)	N/A
	X Walk 1 Slope (%)	1.9		X Walk 2 Slope (%)	N/A
	X Walk 1 X Slope (%)	0.9		X Walk 2 X Slope (%)	N/A
N/A	Ramp inside XWalk1?	N/A	N/A	Ramp inside XWalk2?	N/A
	Road Slope (%)	N/A		Clear Space?	N/A
	Road X Slope (%)	N/A	N/A	Clear Space to XWalk (in)	N/A
			N/A	Any Obstruction?	N/A
				Obstruction Type	N/A
			N/A	Storm Grate/Utility Hazard?	N/A
				Storm Grate/Utility Type	N/A
			Yes	Surface Condition? (G/P)	Good
				Curb Slope (%)	N/A

Possible Solutions:

Remove & Replace Entire Ramp.

R304.5.1, R304.2.2
