# Access Compliance Report

## Public Rights-of-Way

### (Curb Ramps)

Intersection ID: 11460	Main Street: PALM_AV	Cross Street: CARDIFF_AV	Location: NE
ADA ID: BE2250F4F569	Ramp Type: PerpDiag	Initial Pass/Fail: Fail	Overall Compliance: No
		Severity Score: 10

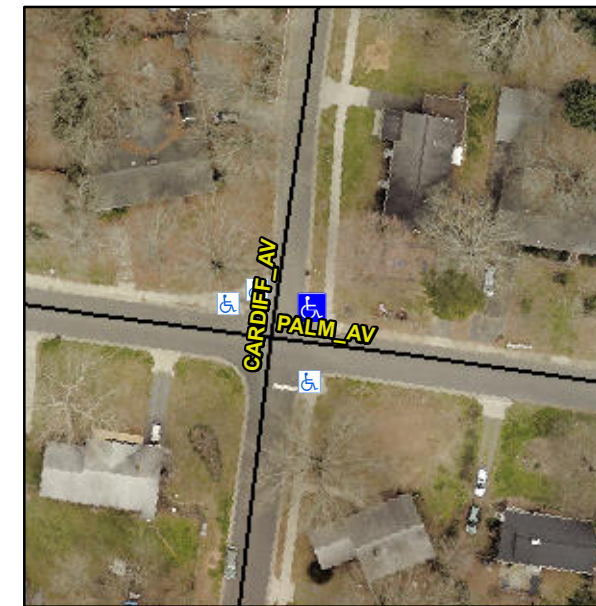
**Not Found, R304.5.1, R304.5.3**

Compliance	Description	Data	Compliance	Description	Data
N/A	Ramp Length (in)	73.5	Yes	Ramp Slope (%)	6.3
No	Ramp Width (in)	45.5	No	Ramp XSlope (%)	4.7
N/A	Flare Type LT	N/A	N/A	Flare Type RT	N/A
N/A	Flare Slope LT (%)	N/A	N/A	Flare Slope RT (%)	N/A
N/A	Flare Traversable LT?	N/A	N/A	Flare Traversable RT?	N/A
N/A	Landing Length (in)	N/A	N/A	DWS Provided?	N/A
N/A	Landing Width (in)	N/A	N/A	DWS Contrast?	N/A
N/A	Landing Slope (%)	N/A	N/A	DWS Length (in)	N/A
N/A	Landing X Slope (%)	N/A	N/A	DWS Full Width?	N/A
N/A	Landing Curb? (Y/N)	N/A	N/A	DWS Offset (in)	N/A
N/A	Shared Landing?	N/A			
N/A	Gutter Ponding?	N/A	N/A	Gutter Slope (%)	N/A
N/A	Gutter Lip Ht (in)	N/A	N/A	Gutter X Slope (%)	N/A
N/A	Painted X Walk1?	No	N/A	Painted X Walk2?	No
	X Walk 1 Direction	To W		X Walk 2 Direction	To S
N/A	X Walk 1 Width (in)	N/A	N/A	X Walk 2 Width (in)	N/A
	X Walk 1 Slope (%)	3.3		X Walk 2 Slope (%)	5.3
	X Walk 1 X Slope (%)	4.5		X Walk 2 X Slope (%)	1.6

N/A	Ramp inside XWalk1?	N/A	N/A	Ramp inside XWalk2?	N/A
	Road Slope (%)	4.9	N/A	Clear Space?	N/A
	Road X Slope (%)	0.5	N/A	Clear Space to XWalk (in)	N/A
N/A	Any Obstructions?	N/A	N/A	Storm Grate/Utility Hazard?	N/A
	Obstruction Type			Storm Grate/Utility Type	
		N/A			N/A
		Yes		Surface Condition? (G/P)	Good

**Remove & Replace Curb Ramp With Two New Directional Ramps or Equivalent.**
