Access Compliance Report

Public Rights-of-Way

(Curb Ramps)

Intersection ID: 10037850	Main Street: SHARON_RD	Cross Street: N/A	Location: NE
ADA ID: BE25971A8D77	Ramp Type: Perp	Initial Pass/Fail: Fail	Overall Compliance: No
			Severity Score: 21.25

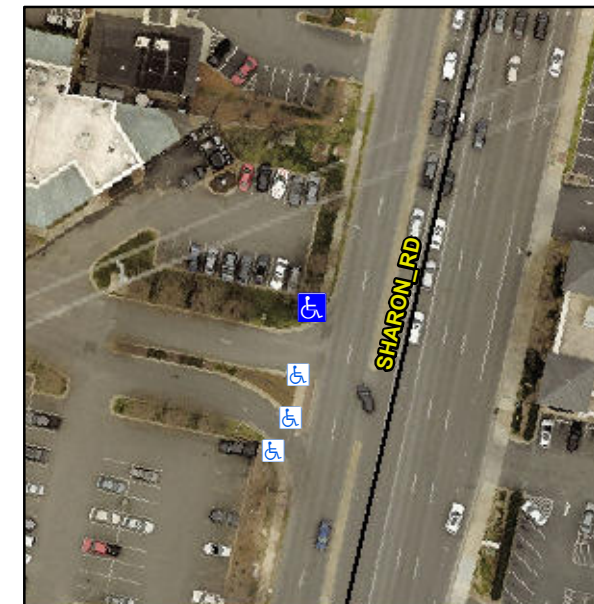
R304.5.1, R304.2.2

Compliance	Description	Data	Compliance	Description	Data
N/A	Ramp Length (in)	62.5	No	Ramp Slope (%)	9.8
No	Ramp Width (in)	46.0	Yes	Ramp XSlope (%)	0.7
N/A	Flare Type LT	N/A	N/A	Flare Type RT	N/A
N/A	Flare Slope LT (%)	N/A	N/A	Flare Slope RT (%)	N/A
N/A	Flare Traversable LT?	N/A	N/A	Flare Traversable RT?	N/A
N/A	Landing Length (in)	N/A	N/A	DWS Provided?	N/A
N/A	Landing Width (in)	N/A	N/A	DWS Contrast?	N/A
N/A	Landing Slope (%)	N/A	N/A	DWS Length (in)	N/A
N/A	Landing X Slope (%)	N/A	N/A	DWS Full Width?	N/A
N/A	Landing Curb? (Y/N)	N/A	N/A	DWS Offset (in)	N/A
N/A	Shared Landing?	N/A			
N/A	Gutter Ponding?	N/A	N/A	Gutter Slope (%)	N/A
N/A	Gutter Lip Ht (in)	N/A	N/A	Gutter X Slope (%)	N/A
N/A	Painted X Walk1?	No	N/A	Painted X Walk2?	N/A
	X Walk 1 Direction	To S		X Walk 2 Direction	N/A
N/A	X Walk 1 Width (in)	N/A	N/A	X Walk 2 Width (in)	N/A
	X Walk 1 Slope (%)	2.3		X Walk 2 Slope (%)	N/A
	X Walk 1 X Slope (%)	0.4		X Walk 2 X Slope (%)	N/A

Remove & Replace Entire Ramp.
