Access Compliance Report

Public Rights-of-Way

(Curb Ramps)

Intersection ID: 42932	Main Street: CARNSORE_CT	Cross Street: HOLLY_PARK_DR	Location: W
ADA ID: BE279A3AF526	Ramp Type: PerpDiag	Initial Pass/Fail: Fail	Overall Compliance: No
Severity Score: 13.75			
Codes/Mitigation Info/Possible Solution		Field Measurements/Component Compliance

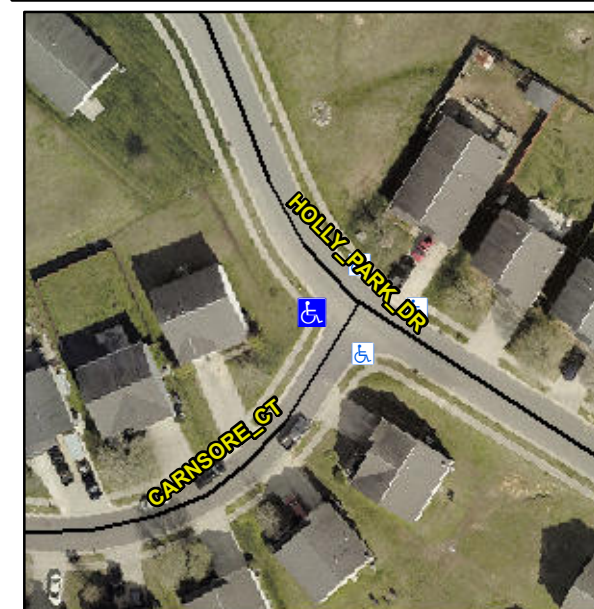
Not Found, R304.2.2, R304.5.3

Compliance	Description	Data	Compliance	Description	Data
N/A	Ramp Length (in)	46.0	No	Ramp Slope (%)	8.4
Yes	Ramp Width (in)	48.0	No	Ramp XSlope (%)	2.4
N/A	Flare Type LT	N/A	N/A	Flare Type RT	N/A
N/A	Flare Slope LT (%)	N/A	N/A	Flare Slope RT (%)	N/A
N/A	Flare Traversable LT?	N/A	N/A	Flare Traversable RT?	N/A
N/A	Landing Length (in)	N/A	N/A	DWS Provided?	N/A
N/A	Landing Width (in)	N/A	N/A	DWS Contrast?	N/A
N/A	Landing Slope (%)	N/A	N/A	DWS Length (in)	N/A
N/A	Landing X Slope (%)	N/A	N/A	DWS Full Width?	N/A
N/A	Landing Curb? (Y/N)	N/A	N/A	DWS Offset (in)	N/A
N/A	Shared Landing?	N/A			
N/A	Gutter Ponding?	N/A	N/A	Gutter Slope (%)	N/A
N/A	Gutter Lip Ht (in)	N/A	N/A	Gutter X Slope (%)	N/A
N/A	Painted X Walk1?	No	N/A	Painted X Walk2?	No
	X Walk 1 Direction	To SE		X Walk 2 Direction	To NE
N/A	X Walk 1 Width (in)	N/A	N/A	X Walk 2 Width (in)	N/A
	X Walk 1 Slope (%)	4.6		X Walk 2 Slope (%)	5.9
	X Walk 1 X Slope (%)	2.7		X Walk 2 X Slope (%)	5.4

N/A	Ramp inside XWalk1?	N/A	N/A	Ramp inside XWalk2?	N/A
	Road Slope (%)	0.8	N/A	Clear Space?	N/A
	Road X Slope (%)	9.9	N/A	Clear Space to XWalk (in)	N/A
N/A	Any Obstructions?	N/A	N/A	Storm Grate/Utility Hazard?	N/A
	Obstruction Type			Storm Grate/Utility Type	
		N/A			N/A
		Yes		Surface Condition? (G/P)	Good

Possible Solutions:

Remove & Replace Curb Ramp With Two New Directional Ramps or Equivalent.
