Access Compliance Report

Public Rights-of-Way

(Curb Ramps)

Intersection ID: 14500	Main Street: MCDONALD_AV	Cross Street: SOUTH_BV	Location: S
ADA ID: BE28F6B0DA11	Ramp Type: Directional1	Initial Pass/Fail: Fail	Overall Compliance: No
Severity Score: 8.75			
Codes/Mitigation Info/Possible Solution		Field Measurements/Component Compliance

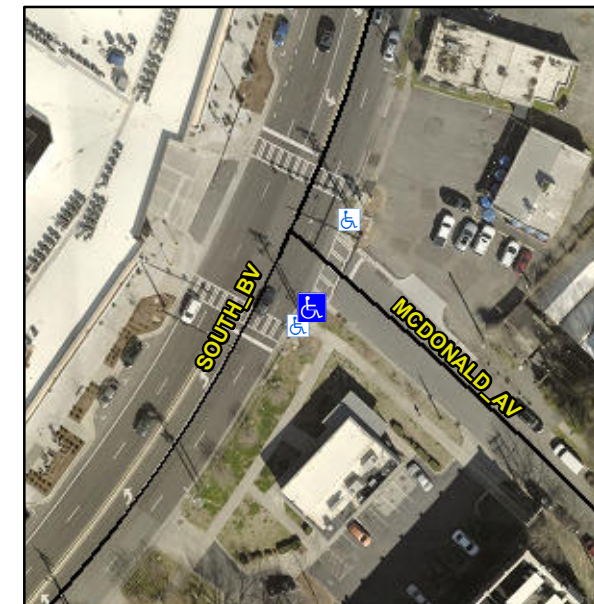
NO CURB LINE

Compliance	Description	Data	Compliance	Description	Data
N/A	Ramp Length (in)	82.0	N/A	Grade Break?	N/A
No	Ramp Width (in)	47.0	N/A	Grade Break Slope (%)	0.0
Yes	Ramp Slope (%)	7.0	N/A	Grade Break XSlope (%)	0.0
Yes	Ramp XSlope (%)	1.7			
N/A	Flare Type LT	N/A	N/A	Flare Type RT	N/A
N/A	Flare Slope LT (%)	N/A	N/A	Flare Slope RT (%)	0.0
N/A	Flare Traversable LT?	N/A	N/A	Flare Traversable RT?	N/A
N/A	Landing Length (in)	0.0	N/A	DWS Provided?	N/A
N/A	Landing Width (in)	0.0	N/A	DWS Contrast?	N/A
N/A	Landing Slope (%)	0.0	N/A	DWS Length (in)	N/A
N/A	Landing X Slope (%)	0.0	N/A	DWS Full Width?	N/A
N/A	Landing Curb? (Y/N)	N/A	N/A	DWS Offset LT (in)	N/A
N/A	Shared Landing?	N/A	N/A	DWS Offset RT (in)	N/A
N/A	Gutter Ponding?	0.0	N/A	Gutter Slope (%)	N/A
N/A	Gutter Lip Ht (in)	0.0	N/A	Gutter X Slope (%)	N/A
N/A	Painted X Walk1?	No		Road Slope (%)	7.5
	X Walk 1 Direction	To NE		Road X Slope (%)	5.7
	X Walk 1 Width (in)	N/A		Clear Space?	N/A

X Walk 1 Slope (%)	7.5	N/A	Clear Space to XWalk (in)	N/A
	X Walk 1 X Slope (%)	5.7	N/A	Storm Grate/Utility Hazard?	N/A
N/A	Ramp inside XWalk1?	N/A		Storm Grate/Utility Type	
N/A	Any Obstructions?	N/A			N/A
	Obstruction Type		Yes	Surface Condition? (G/P)	Good
			N/A	Curb Slope (%)	N/A

Possible Solutions:

Remove & Replace Entire Ramp.
