## Access Compliance Report Public Rights-of-Way (Curb Ramps)

Intersection ID: 10039767Main Street: TODDINGTON\_LNCross Street: N/ALocation:EADA ID: BE2AC7960D44Ramp Type: PerpInitial Pass/Fail: PassOverall Compliance: NoSeverity Score:5

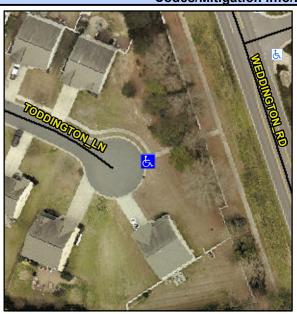
Field Measurements/Component Compliance						
Comp	oliance Description	Data	Comp	liance Description	Data	
N/A	Ramp Length (in)	54.0	Yes	Ramp Slope (%)	5.5	
Yes	Ramp Width (in)	48.0	Yes	Ramp XSlope (%)	2.0	
N/A	Flare Type LT	Sloped	N/A	Flare Type RT	N/A	
N/A	Flare Slope LT (%)	9.1	N/A	Flare Slope RT (%)	5.3	
N/A	Flare Traversable LT?	No	N/A	Flare Traversable RT?	No	
Yes	Landing Length (in)	48.5	Yes	DWS Provided?	Yes	
Yes	Landing Width (in)	61.0	Yes	DWS Contrast?	Yes	
No	Landing Slope (%)	4.5	Yes	DWS Length (in)	24.0	
Yes	Landing X Slope (%)	1.5	Yes	DWS Full Width?	Yes	
N/A	Landing Curb? (Y/N)	No	Yes	DWS Offset (in)	0.0	
N/A	Shared Landing?	No				
Yes	Gutter Ponding?	No	No	Gutter Slope (%)	5.8	
Yes	Gutter Lip Ht (in)	0.0	No	Gutter X Slope (%)	N/A	
N/A	Painted X Walk1?	No	N/A	Painted X Walk2?	N/A	
	X Walk 1 Direction	To W		X Walk 2 Direction	N/A	
N/A	X Walk 1 Width (in)	N/A	N/A	X Walk 2 Width (in)	N/A	
	X Walk 1 Slope (%)	3.2		X Walk 2 Slope (%)	N/A

X Walk 1 X Slope (%)	5.8		X Walk 2 X Slope (%)	N/A	
N/A	Ramp inside XWalk1?	N/A	N/A	Ramp inside XWalk2?	N/A	
	Road Slope (%)	N/A	N/A	Clear Space?	Yes	
	Road X Slope (%)	N/A	N/A	Clear Space to XWalk (in)	N/A	
Yes	Any Obstructions?	No	Yes	Storm Grate/Utility Hazard?	No	
	Obstruction Type			Storm Grate/Utility Type		
		N/A			N/A	
			Yes	Surface Condition? (G/P)	Good	
	100 0 0 0 0 0 0 0 0 0 0 0 0 0 0 0 0 0 0	·	-

Possible Solutions:
Remove & Replace Landing. Remove & Replace Gutter.
Surveyor Notes:
N/A
PROW/ADA:
R304.2.2-Perp, R304.3.2-Para, R304.5.4, R304.5.3
•
