Access Compliance Report

Public Rights-of-Way

(Curb Ramps)

Intersection ID: 13002	Main Street: CENTRAL_AV	Cross Street: PIEDMONT_ST	Location: SE
ADA ID: BE3FACDBC2DD	Ramp Type: Perp	Initial Pass/Fail: Fail	Overall Compliance: No
Severity Score: 12.5			
Codes/Mitigation Info/Possible Solution		Field Measurements/Component Compliance

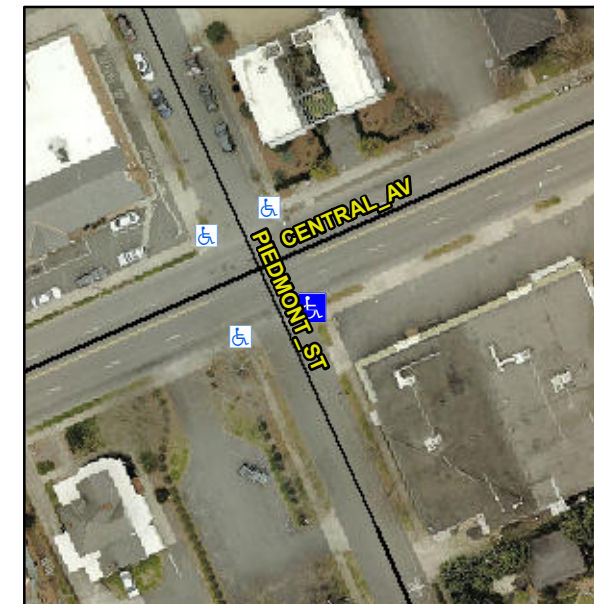
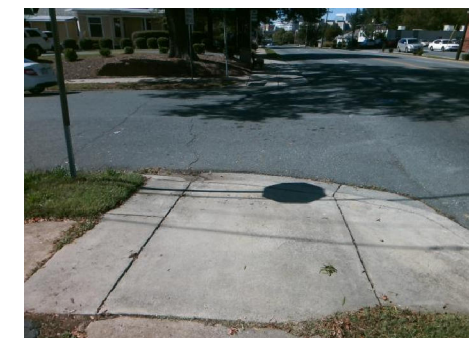
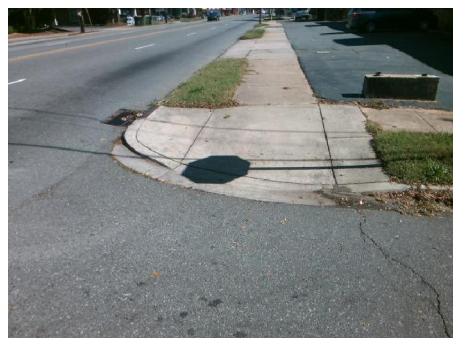
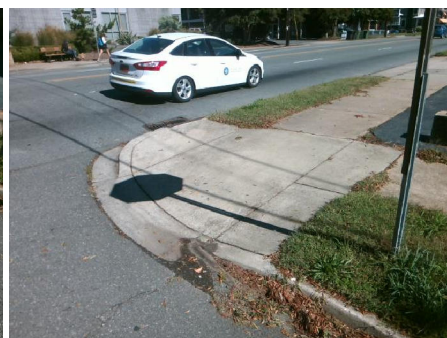
Not Found, R304.2.2

Compliance	Description	Data	Compliance	Description	Data
N/A	Ramp Length (in)	60.0	No	Ramp Slope (%)	9.4
Yes	Ramp Width (in)	74.0	Yes	Ramp XSlope (%)	0.4
N/A	Flare Type LT	N/A	N/A	Flare Type RT	N/A
N/A	Flare Slope LT (%)	N/A	N/A	Flare Slope RT (%)	N/A
N/A	Flare Traversable LT?	N/A	N/A	Flare Traversable RT?	N/A
N/A	Landing Length (in)	N/A	N/A	DWS Provided?	N/A
N/A	Landing Width (in)	N/A	N/A	DWS Contrast?	N/A
N/A	Landing Slope (%)	N/A	N/A	DWS Length (in)	N/A
N/A	Landing X Slope (%)	N/A	N/A	DWS Full Width?	N/A
N/A	Landing Curb? (Y/N)	N/A	N/A	DWS Offset (in)	N/A
N/A	Shared Landing?	N/A			
N/A	Gutter Ponding?	N/A	N/A	Gutter Slope (%)	N/A
N/A	Gutter Lip Ht (in)	0.5	N/A	Gutter X Slope (%)	N/A
N/A	Painted X Walk1?	No	N/A	Painted X Walk2?	N/A
	X Walk 1 Direction	To W		X Walk 2 Direction	N/A
N/A	X Walk 1 Width (in)	N/A	N/A	X Walk 2 Width (in)	N/A
	X Walk 1 Slope (%)	2.7		X Walk 2 Slope (%)	N/A
	X Walk 1 X Slope (%)	3.6		X Walk 2 X Slope (%)	N/A

N/A	Ramp inside XWalk1?	N/A	N/A	Ramp inside XWalk2?	N/A
	Road Slope (%)	N/A	N/A	Clear Space?	N/A
	Road X Slope (%)	N/A	N/A	Clear Space to XWalk (in)	N/A
N/A	Any Obstructions?	N/A	N/A	Storm Grate/Utility Hazard?	N/A
	Obstruction Type			Storm Grate/Utility Type	
		N/A			N/A
			Yes	Surface Condition? (G/P)	Good

Possible Solutions:

Remove & Replace Entire Ramp.
