Access Compliance Report

Public Rights-of-Way

(Curb Ramps)

Intersection ID: 5912	Main Street: BLACK_CHERRY_DR	Cross Street: FOREST_POND_DR	Location: SW
ADA ID: BE48ED239F03	Ramp Type: Perp	Initial Pass/Fail: Fail	Overall Compliance: No
Severity Score: 21.25			
Codes/Mitigation Info/Possible Solution		Field Measurements/Component Compliance

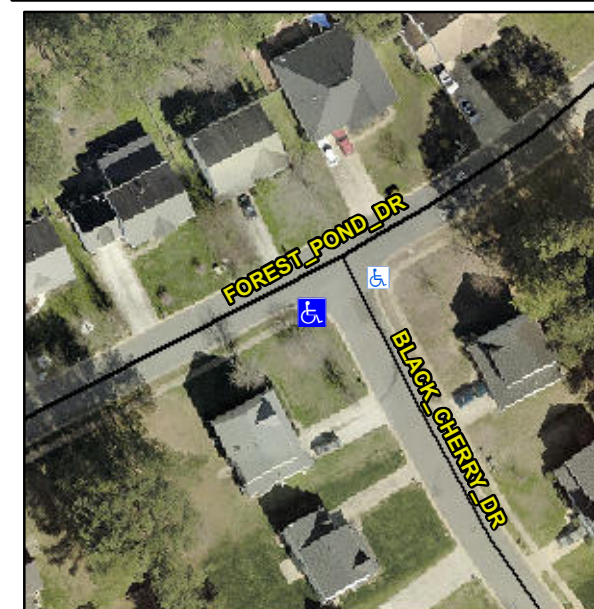
Not Found, R304.5.1, R304.2.2

Compliance	Description	Data	Compliance	Description	Data
N/A	Ramp Length (in)	100.0	No	Ramp Slope (%)	8.4
No	Ramp Width (in)	46.0	Yes	Ramp XSlope (%)	0.5
N/A	Flare Type LT	N/A	N/A	Flare Type RT	N/A
N/A	Flare Slope LT (%)	N/A	N/A	Flare Slope RT (%)	N/A
N/A	Flare Traversable LT?	N/A	N/A	Flare Traversable RT?	N/A
N/A	Landing Length (in)	N/A	N/A	DWS Provided?	N/A
N/A	Landing Width (in)	N/A	N/A	DWS Contrast?	N/A
N/A	Landing Slope (%)	N/A	N/A	DWS Length (in)	N/A
N/A	Landing X Slope (%)	N/A	N/A	DWS Full Width?	N/A
N/A	Landing Curb? (Y/N)	N/A	N/A	DWS Offset (in)	N/A
N/A	Shared Landing?	N/A			
N/A	Gutter Ponding?	N/A	N/A	Gutter Slope (%)	N/A
N/A	Gutter Lip Ht (in)	N/A	N/A	Gutter X Slope (%)	N/A
N/A	Painted X Walk1?	No	N/A	Painted X Walk2?	N/A
	X Walk 1 Direction	To E		X Walk 2 Direction	N/A
N/A	X Walk 1 Width (in)	N/A	N/A	X Walk 2 Width (in)	N/A
	X Walk 1 Slope (%)	0.5		X Walk 2 Slope (%)	N/A
	X Walk 1 X Slope (%)	4.3		X Walk 2 X Slope (%)	N/A

N/A	Ramp inside XWalk1?	N/A	N/A	Ramp inside XWalk2?	N/A
	Road Slope (%)	N/A	N/A	Clear Space?	N/A
	Road X Slope (%)	N/A	N/A	Clear Space to XWalk (in)	N/A
N/A	Any Obstructions?	N/A	N/A	Storm Grate/Utility Hazard?	N/A
	Obstruction Type			Storm Grate/Utility Type	
		N/A			N/A
		Yes		Surface Condition? (G/P)	Good

Possible Solutions:

Remove & Replace Entire Ramp.
