# Access Compliance Report

## Public Rights-of-Way

### (Curb Ramps)

Intersection ID: 11987	Main Street: AIRLIE_ST	Cross Street: COUNTRY CLUB_DR	Location: NW
ADA ID: BE4D7CFB06D3	Ramp Type: Perp	Initial Pass/Fail: Fail	Overall Compliance: No
			Severity Score: 33.75

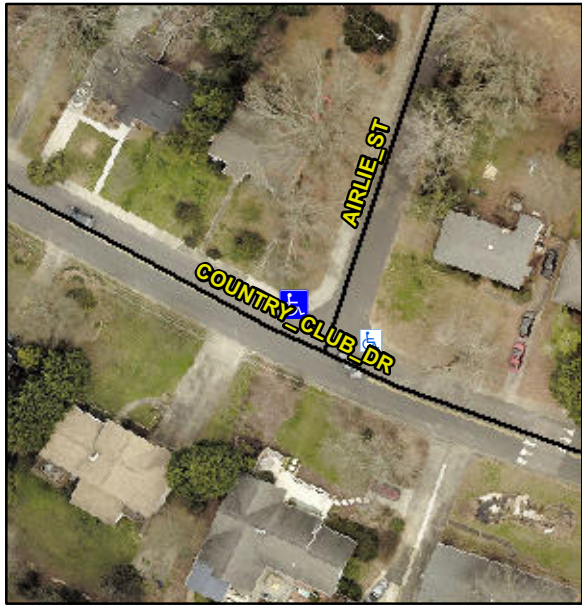
Possible Solutions:		Compliance	Description	Data	Compliance	Description	Data
	Remove & Replace Entire Ramp.		N/A	Ramp Length (in)	70.0	Yes	Ramp Slope (%)	7.3
			No	Ramp Width (in)	44.5	No	Ramp XSlope (%)	8.9
			N/A	Flare Type LT	N/A	N/A	Flare Type RT	N/A
			N/A	Flare Slope LT (%)	N/A	N/A	Flare Slope RT (%)	N/A
			N/A	Flare Traversable LT?	N/A	N/A	Flare Traversable RT?	N/A
			N/A	Landing Length (in)	N/A	N/A	DWS Provided?	N/A
			N/A	Landing Width (in)	N/A	N/A	DWS Contrast?	N/A
			N/A	Landing Slope (%)	N/A	N/A	DWS Length (in)	N/A
			N/A	Landing X Slope (%)	N/A	N/A	DWS Full Width?	N/A
Surveyor Notes:			N/A	Landing Curb? (Y/N)	N/A	N/A	DWS Offset (in)	N/A
PROW/ADA:			N/A	Shared Landing?	N/A			
Not Found, R304.5.1, R304.5.3			N/A	Gutter Ponding?	N/A	N/A	Gutter Slope (%)	N/A
			N/A	Gutter Lip Ht (in)	N/A	N/A	Gutter X Slope (%)	N/A

N/A	Painted X Walk1?	No	N/A	Painted X Walk2?	N/A
				X Walk 1 Direction	To SE		X Walk 2 Direction	N/A
			N/A	X Walk 1 Width (in)	N/A	N/A	X Walk 2 Width (in)	N/A
				X Walk 1 Slope (%)	3.8		X Walk 2 Slope (%)	N/A
				X Walk 1 X Slope (%)	7.9		X Walk 2 X Slope (%)	N/A
			N/A	Ramp inside XWalk1?	N/A	N/A	Ramp inside XWalk2?	N/A
				Road Slope (%)	N/A	N/A	Clear Space?	N/A
				Road X Slope (%)	N/A	N/A	Clear Space to XWalk (in)	N/A
			N/A	Any Obstructions?	N/A	N/A	Storm Grate/Utility Hazard?	N/A
				Obstruction Type			Storm Grate/Utility Type	
					N/A			N/A
						Yes	Surface Condition? (G/P)	Good
