Access Compliance Report

Public Rights-of-Way

(Curb Ramps)

Intersection ID: 28106	Main Street: TOLLIVER_DR	Cross Street: GUNNISON_LN	Location: SE
ADA ID: BE59F6FB3C5C	Ramp Type: PerpDiag	Initial Pass/Fail: Fail	Overall Compliance: No
Severity Score: 37.5			
Codes/Mitigation Info/Possible Solution		Field Measurements/Component Compliance

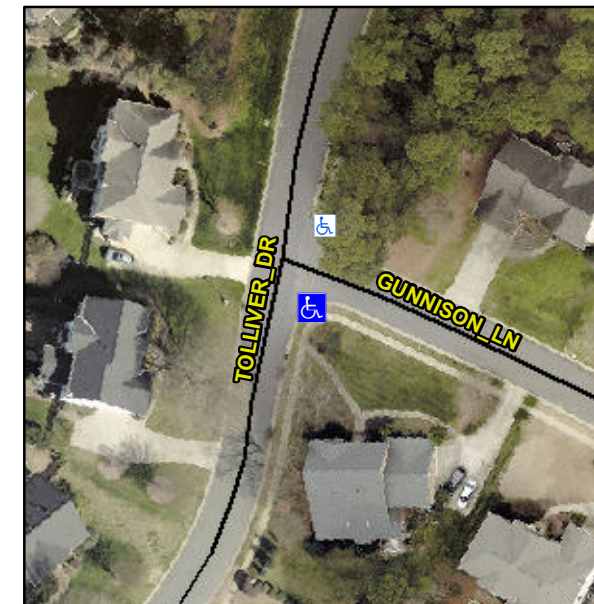
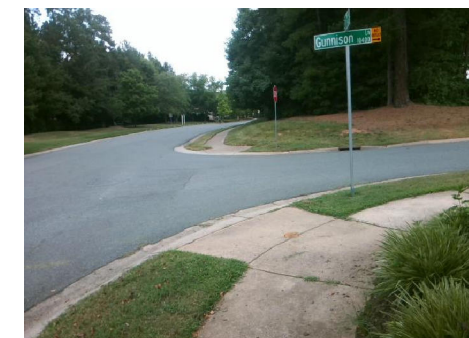
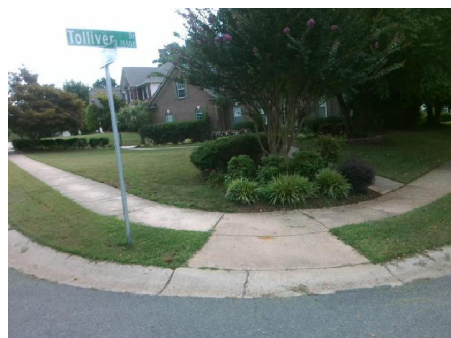
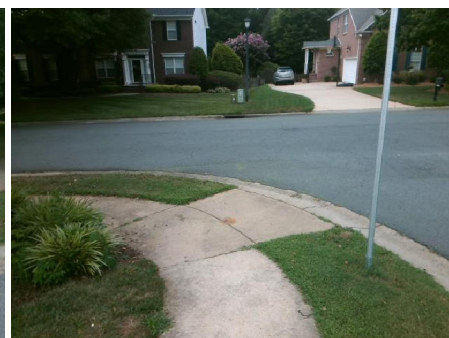
Not Found, R304.2.2, R304.5.3

Compliance	Description	Data	Compliance	Description	Data
N/A	Ramp Length (in)	100.5	No	Ramp Slope (%)	9.2
Yes	Ramp Width (in)	48.0	No	Ramp XSlope (%)	8.9
N/A	Flare Type LT	N/A	N/A	Flare Type RT	N/A
N/A	Flare Slope LT (%)	N/A	N/A	Flare Slope RT (%)	N/A
N/A	Flare Traversable LT?	N/A	N/A	Flare Traversable RT?	N/A
N/A	Landing Length (in)	N/A	N/A	DWS Provided?	N/A
N/A	Landing Width (in)	N/A	N/A	DWS Contrast?	N/A
N/A	Landing Slope (%)	N/A	N/A	DWS Length (in)	N/A
N/A	Landing X Slope (%)	N/A	N/A	DWS Full Width?	N/A
N/A	Landing Curb? (Y/N)	N/A	N/A	DWS Offset (in)	N/A
N/A	Shared Landing?	N/A			
N/A	Gutter Ponding?	N/A	N/A	Gutter Slope (%)	N/A
N/A	Gutter Lip Ht (in)	N/A	N/A	Gutter X Slope (%)	N/A
N/A	Painted X Walk1?	No	N/A	Painted X Walk2?	No
	X Walk 1 Direction	To NE		X Walk 2 Direction	To W
N/A	X Walk 1 Width (in)	N/A	N/A	X Walk 2 Width (in)	N/A
	X Walk 1 Slope (%)	1.3		X Walk 2 Slope (%)	0.5
	X Walk 1 X Slope (%)	3.0		X Walk 2 X Slope (%)	2.0

N/A	Ramp inside XWalk1?	N/A	N/A	Ramp inside XWalk2?	N/A
	Road Slope (%)	5.2	N/A	Clear Space?	N/A
	Road X Slope (%)	0.1	N/A	Clear Space to XWalk (in)	N/A
N/A	Any Obstructions?	N/A	N/A	Storm Grate/Utility Hazard?	N/A
	Obstruction Type			Storm Grate/Utility Type	
		N/A			N/A
		Yes		Surface Condition? (G/P)	Good

Remove & Replace Curb Ramp With Two New Directional Ramps or Equivalent.
