Access Compliance Report

Public Rights-of-Way

(Curb Ramps)

Intersection ID: 10014544	Main Street: BROOKSIDE_LN	Cross Street: N/A	Location: NE
ADA ID: BE5D54B347C5	Ramp Type: BlendTrans1	Initial Pass/Fail: Fail	Overall Compliance: No
		Severity Score: 25

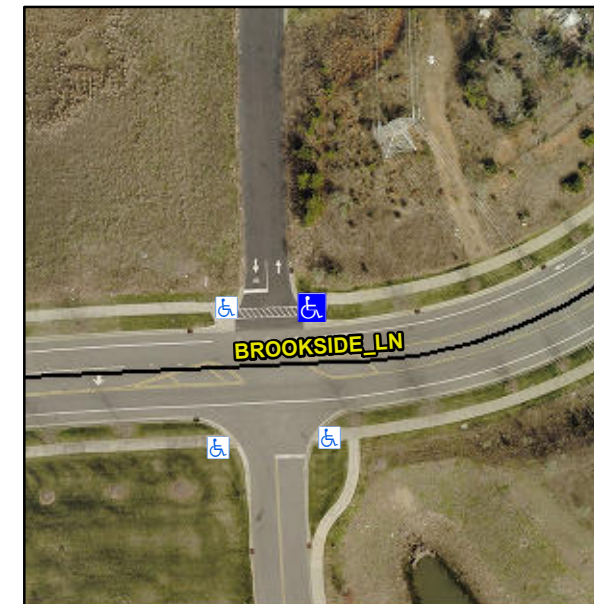
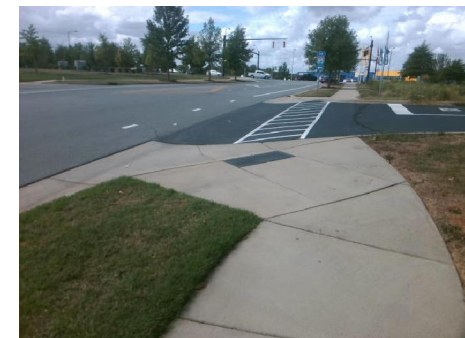
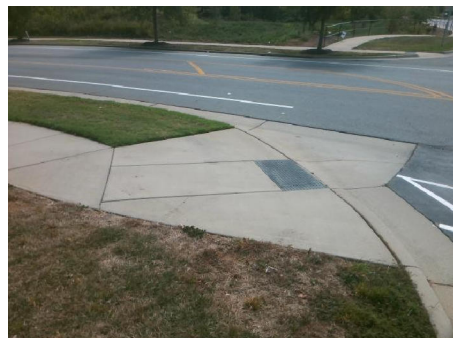
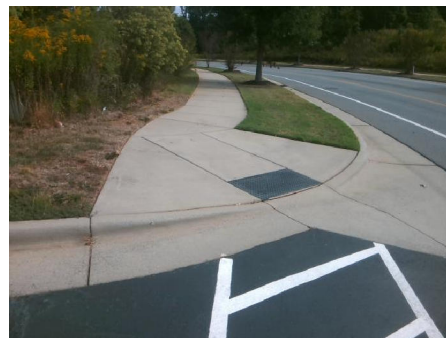
Not Found, R304.5.3

Compliance	Description	Data	Compliance	Description	Data
N/A	Ramp Length (in)	107.0	Yes	BlendTrans Slope (%)	3.5
Yes	Ramp Width (in)	48.0	No	BlendTrans XSlope (%)	13.2
N/A	Flare Type LT	N/A	N/A	Flare Type RT	N/A
N/A	Flare Slope LT (%)	N/A	N/A	Flare Slope RT (%)	N/A
N/A	Flare Traversable LT?	N/A	N/A	Flare Traversable RT?	N/A
N/A	Landing Length (in)	N/A	N/A	DWS Provided?	N/A
N/A	Landing Width (in)	N/A	N/A	DWS Contrast?	N/A
N/A	Landing Slope (%)	N/A	N/A	DWS Length (in)	N/A
N/A	Landing X Slope (%)	N/A	N/A	DWS Full Width?	N/A
N/A	Landing Curb? (Y/N)	N/A	N/A	DWS Offset (in)	N/A
N/A	Shared Landing?	N/A			
N/A	Gutter Ponding?	N/A	N/A	Gutter Slope (%)	N/A
N/A	Gutter Lip Ht (in)	N/A	N/A	Gutter X Slope (%)	N/A
N/A	Painted X Walk1?	Yes	N/A	Painted X Walk2?	No
	X Walk 1 Direction	To W		X Walk 2 Direction	To S
	X Walk 1 Width (in)	52.0		X Walk 2 Width (in)	N/A
	X Walk 1 Slope (%)	2.0		X Walk 2 Slope (%)	0.7
	X Walk 1 X Slope (%)	8.7		X Walk 2 X Slope (%)	4.3

N/A	Ramp inside XWalk1?	Yes	N/A	Ramp inside XWalk2?	N/A
	Road Slope (%)	13.2		Clear Space?	N/A
	Road X Slope (%)	2.8	N/A	Clear Space to XWalk (in)	N/A
N/A	Any Obstructions?	N/A	N/A	Storm Grate/Utility Hazard?	N/A
	Obstruction Type			Storm Grate/Utility Type	
		N/A			N/A
		Yes		Surface Condition? (G/P)	Good
		No		Curb Slope (%)	6.9

Remove & Replace Curb Ramp With Two New Directional Ramps or Equivalent.
