# Access Compliance Report

## Public Rights-of-Way

### (Curb Ramps)

Intersection ID: 10038340	Main Street: SOUTH_BV	Cross Street: N/A	Location: N
ADA ID: BE5F79E5F192	Ramp Type: Para	Initial Pass/Fail: Fail	Overall Compliance: No
		Severity Score: 12.5

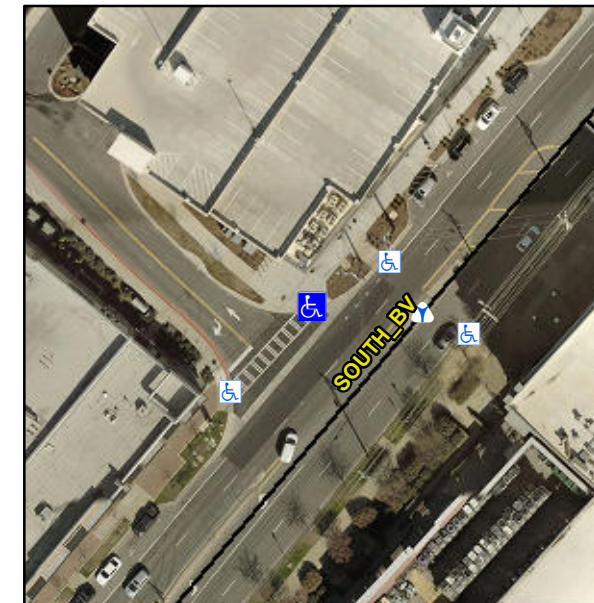
**NO LNDG**

**R304.3.2**

Compliance	Description	Data	Compliance	Description	Data
N/A	Ramp Length LT (in)	67.0	N/A	Ramp Length RT (in)	66.0
Yes	Ramp Width LT (in)	72.0	Yes	Ramp Width RT (in)	71.0
No	Ramp Slope LT (%)	9.4	Yes	Ramp Slope RT (%)	5.1
Yes	Ramp XSlope LT (%)	1.0	Yes	Ramp XSlope RT (%)	1.7
N/A	Landing Length (in)	N/A	N/A	DWS Provided?	N/A
N/A	Landing Width (in)	N/A	N/A	DWS Contrast?	N/A
N/A	Landing Slope (%)	N/A	N/A	DWS Length (in)	N/A
N/A	Landing X Slope (%)	N/A	N/A	DWS Full Width?	N/A
N/A	Landing Curb? (Y/N)	N/A	N/A	DWS Offset (in)	N/A
N/A	Shared Landing?	N/A			
N/A	Gutter Ponding?	N/A	N/A	Gutter Slope (%)	N/A
N/A	Gutter Lip Ht (in)	N/A	N/A	Gutter X Slope (%)	N/A
N/A	Painted X Walk1?	Yes	N/A	Painted X Walk2?	N/A
	X Walk 1 Direction	To SW		X Walk 2 Direction	N/A
N/A	X Walk 1 Width (in)	112.0	N/A	X Walk 2 Width (in)	N/A
	X Walk 1 Slope (%)	0.0		X Walk 2 Slope (%)	N/A
	X Walk 1 X Slope (%)	3.4		X Walk 2 X Slope (%)	N/A
N/A	Ramp inside XWalk1?	Yes	N/A	Ramp inside XWalk2?	N/A

Road Slope (%)	N/A	N/A	Clear Space?	N/A
	Road X Slope (%)	N/A	N/A	Clear Space to XWalk (in)	N/A
N/A	Any Obstructions?	N/A	N/A	Storm Grate/Utility Hazard?	N/A
	Obstruction Type			Storm Grate/Utility Type	
		N/A			N/A
			Yes	Surface Condition? (G/P)	Good
			N/A	Curb Slope (%)	5.1

**Remove & Replace Entire Ramp.**
