# Access Compliance Report

## Public Rights-of-Way

### (Curb Ramps)

Intersection ID: 8014	Main Street: MORGAN_ST	Cross Street: SAMPSON_ST	Location:	N
ADA ID: BE6A26625461	Ramp Type: BlendTrans2	Initial Pass/Fail: Fail	Overall Compliance: No	Severity Score: 10

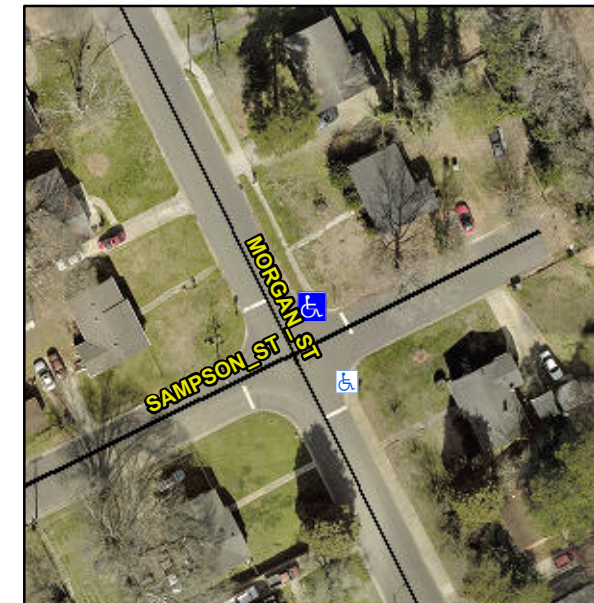
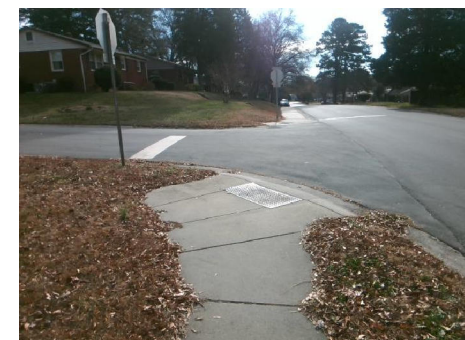
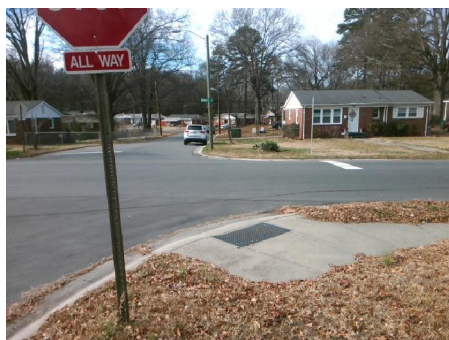
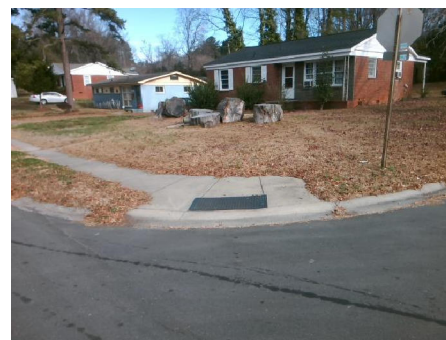
**NO RT SW**

**R304.5.1, R304.5.3**

Compliance	Description	Data	Compliance	Description	Data
N/A	Ramp Length (in)	84.0	Yes	BlendTrans Slope (%)	3.2
No	Ramp Width (in)	46.5	No	BlendTrans XSlope (%)	3.7
N/A	Flare Type LT	N/A	N/A	Flare Type RT	N/A
N/A	Flare Slope LT (%)	N/A	N/A	Flare Slope RT (%)	N/A
N/A	Flare Traversable LT?	N/A	N/A	Flare Traversable RT?	N/A
N/A	Landing Length (in)	N/A	N/A	DWS Provided?	N/A
N/A	Landing Width (in)	N/A	N/A	DWS Contrast?	N/A
N/A	Landing Slope (%)	N/A	N/A	DWS Length (in)	N/A
N/A	Landing X Slope (%)	N/A	N/A	DWS Full Width?	N/A
N/A	Landing Curb? (Y/N)	N/A	N/A	DWS Offset (in)	N/A
N/A	Shared Landing?	N/A			
N/A	Gutter Ponding?	N/A	N/A	Gutter Slope (%)	N/A
N/A	Gutter Lip Ht (in)	N/A	N/A	Gutter X Slope (%)	N/A
N/A	Painted X Walk1?	No	N/A	Painted X Walk2?	N/A
	X Walk 1 Direction	To SE		X Walk 2 Direction	N/A
	X Walk 1 Width (in)	N/A		X Walk 2 Width (in)	N/A
	X Walk 1 Slope (%)	2.5		X Walk 2 Slope (%)	N/A
	X Walk 1 X Slope (%)	0.6		X Walk 2 X Slope (%)	N/A

N/A	Ramp inside XWalk1?	N/A	N/A	Ramp inside XWalk2?	N/A
	Road Slope (%)	0.6		Clear Space?	N/A
	Road X Slope (%)	2.5	N/A	Clear Space to XWalk (in)	N/A
N/A	Any Obstructions?	N/A	N/A	Storm Grate/Utility Hazard?	N/A
	Obstruction Type			Storm Grate/Utility Type	
		N/A			N/A
			Yes	Surface Condition? (G/P)	Good
			N/A	Curb Slope (%)	4.7

**Remove & Replace Curb Ramp With Two New Directional Ramps or Equivalent.**
