Access Compliance Report

Public Rights-of-Way

(Curb Ramps)

Intersection ID: 47395	Main Street: OVERLAND_PARK_LN	Cross Street: KENBROOKE_DR	Location: NE
ADA ID: BE6EF8588FB8	Ramp Type: PerpDiag	Initial Pass/Fail: Fail	Overall Compliance: No
		Severity Score: 10

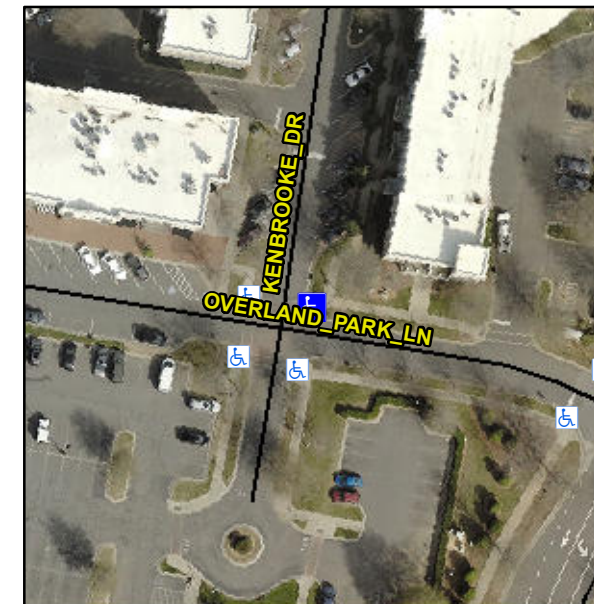
Compliance	Description	Data	Compliance	Description	Data
N/A	Ramp Length (in)	73.5	Yes	Ramp Slope (%)	6.8
No	Ramp Width (in)	36.5	No	Ramp XSlope (%)	2.1
N/A	Flare Type LT	N/A	N/A	Flare Type RT	N/A
N/A	Flare Slope LT (%)	N/A	N/A	Flare Slope RT (%)	N/A
N/A	Flare Traversable LT?	N/A	N/A	Flare Traversable RT?	N/A
N/A	Landing Length (in)	N/A	N/A	DWS Provided?	N/A
N/A	Landing Width (in)	N/A	N/A	DWS Contrast?	N/A
N/A	Landing Slope (%)	N/A	N/A	DWS Length (in)	N/A
N/A	Landing X Slope (%)	N/A	N/A	DWS Full Width?	N/A
N/A	Landing Curb? (Y/N)	N/A	N/A	DWS Offset (in)	N/A
N/A	Shared Landing?	N/A			
N/A	Gutter Ponding?	N/A	N/A	Gutter Slope (%)	N/A
N/A	Gutter Lip Ht (in)	N/A	N/A	Gutter X Slope (%)	N/A
N/A	Painted X Walk1?	Yes	N/A	Painted X Walk2?	Yes
	X Walk 1 Direction	To W		X Walk 2 Direction	To S
N/A	X Walk 1 Width (in)	50.0	N/A	X Walk 2 Width (in)	51.0
	X Walk 1 Slope (%)	3.6		X Walk 2 Slope (%)	0.6
	X Walk 1 X Slope (%)	0.9		X Walk 2 X Slope (%)	4.2

N/A	Ramp inside XWalk1?	Yes	N/A	Ramp inside XWalk2?	Yes
	Road Slope (%)	3.4	N/A	Clear Space?	N/A
	Road X Slope (%)	3.1	N/A	Clear Space to XWalk (in)	N/A
N/A	Any Obstructions?	N/A	N/A	Storm Grate/Utility Hazard?	N/A
	Obstruction Type			Storm Grate/Utility Type	
		N/A			N/A
		Yes		Surface Condition? (G/P)	Good

Remove & Replace Curb Ramp With Two New Directional Ramps or Equivalent.

R304.5.1, R304.5.3
