# Access Compliance Report

## Public Rights-of-Way (Curb Ramps)

| Intersection ID: 25538 | Main Street: HATTON_CROSS_DR | Cross Street: KENSAL_GREEN_DR | Location: | N |
| ADA ID: BE709D0F9D25 | Ramp Type: BlendTrans2 | Initial Pass/Fail: Pass | Overall Compliance: No | Severity Score: 7.5 |

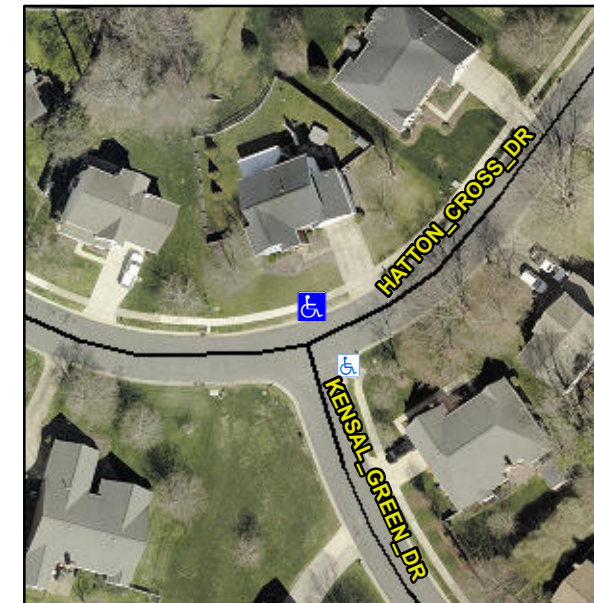
**Not Found, R305.1.4, R305.2, R304.5.4**

| Compliance | Description | Data | Compliance | Description | Data |
|---|---|---|---|---|---|
| N/A | Landing X Slope (%) | N/A | No | DWS Full Width? | No |
| N/A | Landing Curb? (Y/N) | No | No | DWS Offset (in) | 5.5 |
| Yes | Gutter Ponding? | No | No | Gutter Slope (%) | 8.5 |
| | | | No | Curb Slope (%) | 32.4 |

**Remove & Replace Curb Ramp With Two New Directional Ramps or Equivalent. Remove & Replace Gutter.**
