Access Compliance Report

Public Rights-of-Way

(Curb Ramps)

Intersection ID: N/A	Main Street: SCONE_PALACE_CT	Cross Street: N/A	Location: N
ADA ID: BE8CF626E263	Ramp Type: Perp	Initial Pass/Fail: Fail	Overall Compliance: No
		Severity Score: 25

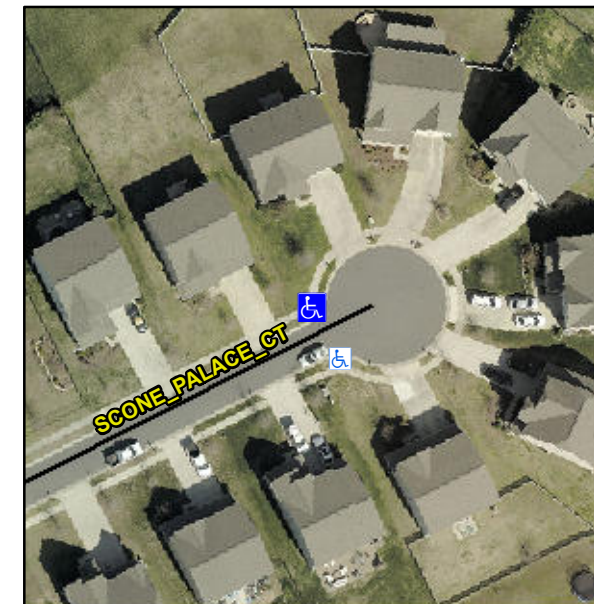
R304.2.2, R304.5.3

Compliance	Description	Data	Compliance	Description	Data
N/A	Ramp Length (in)	49.0	No	Ramp Slope (%)	10.4
Yes	Ramp Width (in)	48.0	No	Ramp XSlope (%)	5.1
N/A	Flare Type LT	N/A	N/A	Flare Type RT	N/A
N/A	Flare Slope LT (%)	N/A	N/A	Flare Slope RT (%)	N/A
N/A	Flare Traversable LT?	N/A	N/A	Flare Traversable RT?	N/A
N/A	Landing Length (in)	N/A	N/A	DWS Provided?	N/A
N/A	Landing Width (in)	N/A	N/A	DWS Contrast?	N/A
N/A	Landing Slope (%)	N/A	N/A	DWS Length (in)	N/A
N/A	Landing X Slope (%)	N/A	N/A	DWS Full Width?	N/A
N/A	Landing Curb? (Y/N)	N/A	N/A	DWS Offset (in)	N/A
N/A	Shared Landing?	N/A			
N/A	Gutter Ponding?	N/A	N/A	Gutter Slope (%)	N/A
N/A	Gutter Lip Ht (in)	N/A	N/A	Gutter X Slope (%)	N/A
N/A	Painted X Walk1?	No	N/A	Painted X Walk2?	N/A
	X Walk 1 Direction	To S		X Walk 2 Direction	N/A
N/A	X Walk 1 Width (in)	N/A	N/A	X Walk 2 Width (in)	N/A
	X Walk 1 Slope (%)	3.1		X Walk 2 Slope (%)	N/A
	X Walk 1 X Slope (%)	4.3		X Walk 2 X Slope (%)	N/A

N/A	Ramp inside XWalk1?	N/A	N/A	Ramp inside XWalk2?	N/A
	Road Slope (%)	N/A	N/A	Clear Space?	N/A
	Road X Slope (%)	N/A	N/A	Clear Space to XWalk (in)	N/A
N/A	Any Obstructions?	N/A	N/A	Storm Grate/Utility Hazard?	N/A
	Obstruction Type			Storm Grate/Utility Type	
		N/A			N/A
			Yes	Surface Condition? (G/P)	Good

Remove & Replace Entire Ramp.

Total Cost: \$ 1850.00
