# Access Compliance Report

## Public Rights-of-Way

### (Curb Ramps)

Intersection ID: 51519	Main Street: E JOHN BELK RA	Cross Street: SOUTH BV	Location: SW
ADA ID: BE9002075714	Ramp Type: Perp	Initial Pass/Fail: Fail	Overall Compliance: No
		Severity Score: 8.75

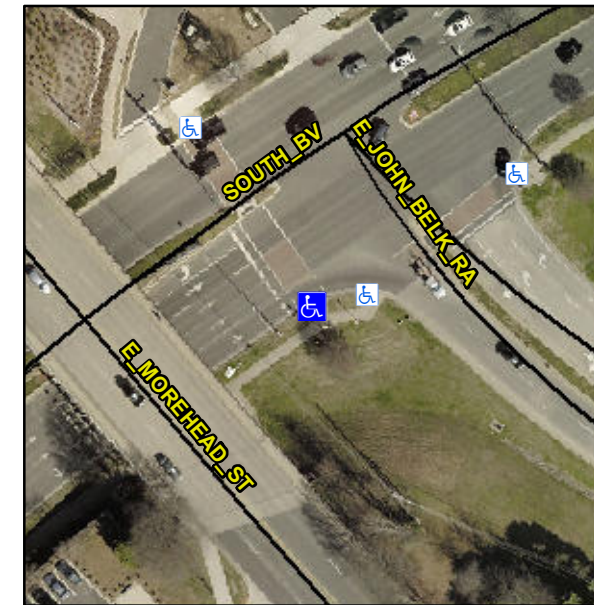
Compliance	Description	Data	Compliance	Description	Data
N/A	Ramp Length (in)	96.0	Yes	Ramp Slope (%)	5.3
No	Ramp Width (in)	47.0	Yes	Ramp XSlope (%)	1.2
N/A	Flare Type LT	N/A	N/A	Flare Type RT	N/A
N/A	Flare Slope LT (%)	N/A	N/A	Flare Slope RT (%)	N/A
N/A	Flare Traversable LT?	N/A	N/A	Flare Traversable RT?	N/A
N/A	Landing Length (in)	N/A	N/A	DWS Provided?	N/A
N/A	Landing Width (in)	N/A	N/A	DWS Contrast?	N/A
N/A	Landing Slope (%)	N/A	N/A	DWS Length (in)	N/A
N/A	Landing X Slope (%)	N/A	N/A	DWS Full Width?	N/A
N/A	Landing Curb? (Y/N)	N/A	N/A	DWS Offset (in)	N/A
N/A	Shared Landing?	N/A			
N/A	Gutter Ponding?	N/A	N/A	Gutter Slope (%)	N/A
N/A	Gutter Lip Ht (in)	N/A	N/A	Gutter X Slope (%)	N/A
N/A	Painted X Walk1?	Yes	N/A	Painted X Walk2?	N/A
	X Walk 1 Direction	To NW		X Walk 2 Direction	N/A
N/A	X Walk 1 Width (in)	188.0	N/A	X Walk 2 Width (in)	N/A
	X Walk 1 Slope (%)	4.8		X Walk 2 Slope (%)	N/A
	X Walk 1 X Slope (%)	1.2		X Walk 2 X Slope (%)	N/A

N/A	Ramp inside XWalk1?	Yes	N/A	Ramp inside XWalk2?	N/A
	Road Slope (%)	N/A	N/A	Clear Space?	N/A
	Road X Slope (%)	N/A	N/A	Clear Space to XWalk (in)	N/A
N/A	Any Obstructions?	N/A	N/A	Storm Grate/Utility Hazard?	N/A
	Obstruction Type			Storm Grate/Utility Type	
		N/A			N/A
			Yes	Surface Condition? (G/P)	Good

**Remove & Replace Entire Ramp.**

**R304.5.1**
