Access Compliance Report

Public Rights-of-Way

(Curb Ramps)

Intersection ID: 26038	Main Street: ELM_LN	Cross Street: PINEVILLE-MATTHEWS_RD	Location: SE
ADA ID: BE989BEE5382	Ramp Type: PerpDiag	Initial Pass/Fail: Fail	Overall Compliance: No
		Severity Score: 10

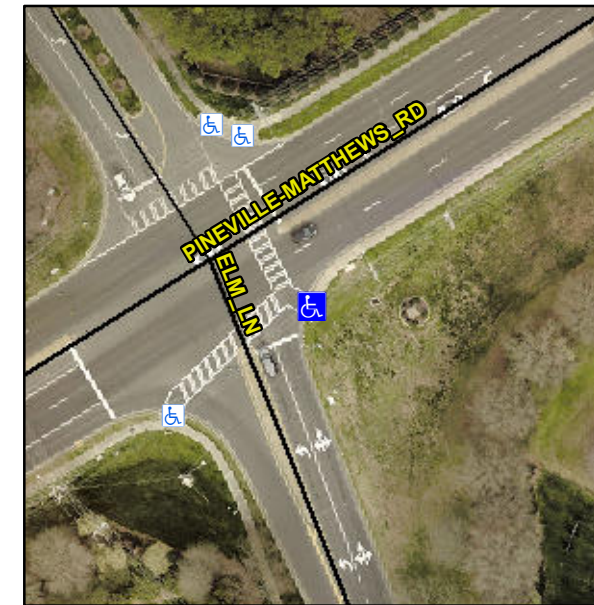
Compliance	Description	Data	Compliance	Description	Data
N/A	Ramp Length (in)	60.0	Yes	Ramp Slope (%)	7.5
No	Ramp Width (in)	40.0	No	Ramp XSlope (%)	2.7
N/A	Flare Type LT	N/A	N/A	Flare Type RT	N/A
N/A	Flare Slope LT (%)	N/A	N/A	Flare Slope RT (%)	N/A
N/A	Flare Traversable LT?	N/A	N/A	Flare Traversable RT?	N/A
N/A	Landing Length (in)	N/A	N/A	DWS Provided?	N/A
N/A	Landing Width (in)	N/A	N/A	DWS Contrast?	N/A
N/A	Landing Slope (%)	N/A	N/A	DWS Length (in)	N/A
N/A	Landing X Slope (%)	N/A	N/A	DWS Full Width?	N/A
N/A	Landing Curb? (Y/N)	N/A	N/A	DWS Offset (in)	N/A
N/A	Shared Landing?	N/A			
N/A	Gutter Ponding?	N/A	N/A	Gutter Slope (%)	N/A
N/A	Gutter Lip Ht (in)	N/A	N/A	Gutter X Slope (%)	N/A
N/A	Painted X Walk1?	No	N/A	Painted X Walk2?	No
	X Walk 1 Direction	To NW		X Walk 2 Direction	To SW
N/A	X Walk 1 Width (in)	N/A	N/A	X Walk 2 Width (in)	N/A
	X Walk 1 Slope (%)	2.4		X Walk 2 Slope (%)	2.0
	X Walk 1 X Slope (%)	0.6		X Walk 2 X Slope (%)	2.8

N/A	Ramp inside XWalk1?	N/A	N/A	Ramp inside XWalk2?	N/A
	Road Slope (%)	0.6	N/A	Clear Space?	N/A
	Road X Slope (%)	2.2	N/A	Clear Space to XWalk (in)	N/A
N/A	Any Obstructions?	N/A	N/A	Storm Grate/Utility Hazard?	N/A
	Obstruction Type			Storm Grate/Utility Type	
		N/A			N/A
		Yes		Surface Condition? (G/P)	Good

Remove & Replace Curb Ramp With Two New Directional Ramps or Equivalent.
