# Access Compliance Report

## Public Rights-of-Way

### (Curb Ramps)

| Intersection ID: 50592 | Main Street: BENDING_BRANCH_RD | Cross Street: BRISTLEY_RD | Location: SE |

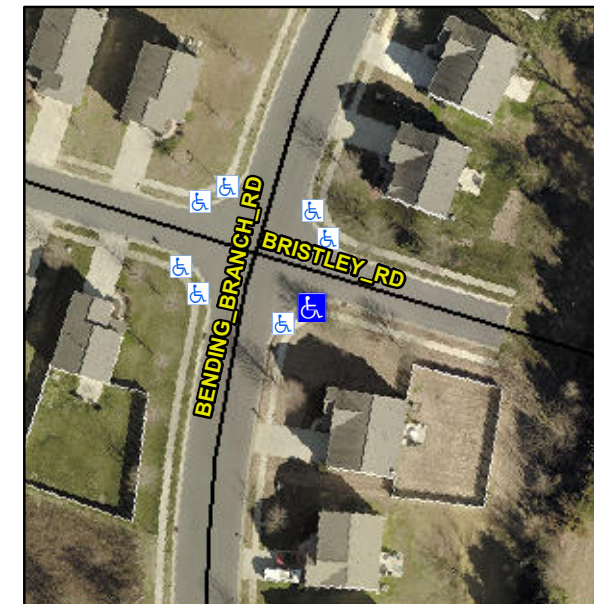
| Severity Score: 5 | | | |

| Compliance | Description | Data | Compliance | Description | Data |
|---|---|---|---|---|---|
| No | Landing Slope (%) | 2.2 | Yes | DWS Length (in) | 24.0 |
| N/A | Landing Curb? (Y/N) | No | No | DWS Offset (in) | 5.0 |
| Yes | Gutter Ponding? | No | No | Gutter Slope (%) | 13.5 |

**Remove & Replace Entire Ramp.  
Remove & Replace Gutter.**

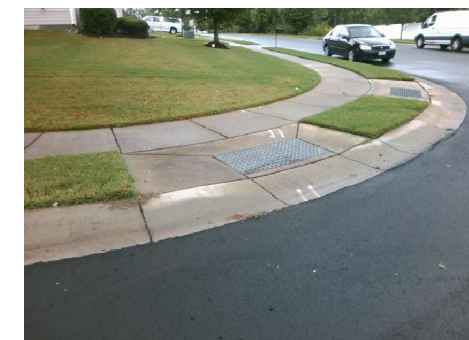
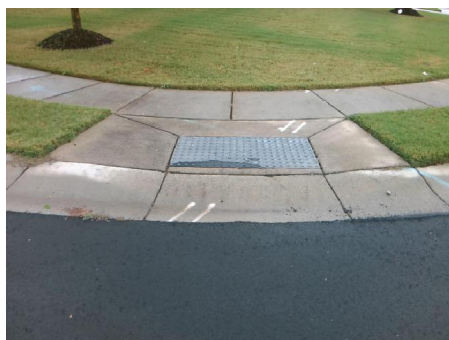
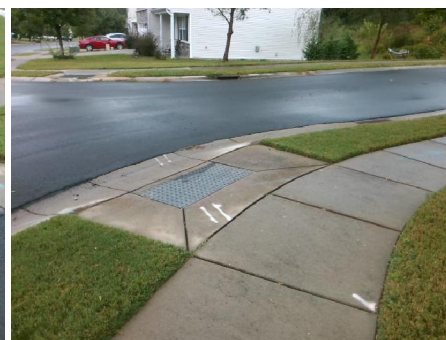
| ADA ID: BE9E933658DC | Ramp Type: Perp | Initial Pass/Fail: Pass | Overall Compliance: No |
