Access Compliance Report

Public Rights-of-Way

(Curb Ramps)

Intersection ID: 7084	Main Street: CEDARHURST_DR	Cross Street: DALECREST_DR	Location: S
ADA ID: BEA2002252A0	Ramp Type: Perp	Initial Pass/Fail: Fail	Overall Compliance: No
Severity Score: 42.5			
Codes/Mitigation Info/Possible Solution		Field Measurements/Component Compliance

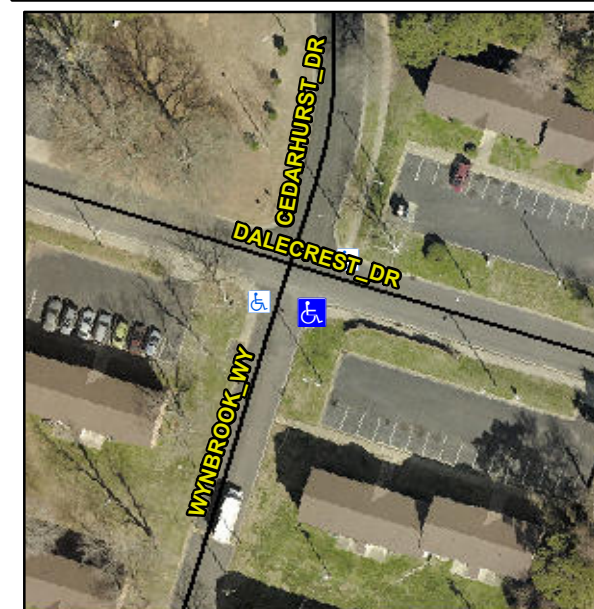
Not Found, R304.5.1, R304.2.2

Compliance	Description	Data	Compliance	Description	Data
N/A	Ramp Length (in)	61.0	No	Ramp Slope (%)	12.1
No	Ramp Width (in)	32.5	Yes	Ramp XSlope (%)	0.8
N/A	Flare Type LT	N/A	N/A	Flare Type RT	N/A
N/A	Flare Slope LT (%)	N/A	N/A	Flare Slope RT (%)	N/A
N/A	Flare Traversable LT?	N/A	N/A	Flare Traversable RT?	N/A
N/A	Landing Length (in)	N/A	N/A	DWS Provided?	N/A
N/A	Landing Width (in)	N/A	N/A	DWS Contrast?	N/A
N/A	Landing Slope (%)	N/A	N/A	DWS Length (in)	N/A
N/A	Landing X Slope (%)	N/A	N/A	DWS Full Width?	N/A
N/A	Landing Curb? (Y/N)	N/A	N/A	DWS Offset (in)	N/A
N/A	Shared Landing?	N/A			
N/A	Gutter Ponding?	N/A	N/A	Gutter Slope (%)	N/A
N/A	Gutter Lip Ht (in)	N/A	N/A	Gutter X Slope (%)	N/A
N/A	Painted X Walk1?	No	N/A	Painted X Walk2?	N/A
	X Walk 1 Direction	To NW		X Walk 2 Direction	N/A
N/A	X Walk 1 Width (in)	N/A	N/A	X Walk 2 Width (in)	N/A
	X Walk 1 Slope (%)	0.5		X Walk 2 Slope (%)	N/A
	X Walk 1 X Slope (%)	1.8		X Walk 2 X Slope (%)	N/A

N/A	Ramp inside XWalk1?	N/A	N/A	Ramp inside XWalk2?	N/A
	Road Slope (%)	N/A	N/A	Clear Space?	N/A
	Road X Slope (%)	N/A	N/A	Clear Space to XWalk (in)	N/A
N/A	Any Obstructions?	N/A	N/A	Storm Grate/Utility Hazard?	N/A
	Obstruction Type			Storm Grate/Utility Type	
		N/A			N/A
			Yes	Surface Condition? (G/P)	Good

Possible Solutions:

Remove & Replace Entire Ramp.

Total Cost: \$ 1850.00
