# Access Compliance Report

## Public Rights-of-Way (Curb Ramps)

Intersection ID: 8578	Main Street: DARE_DR	Cross Street: HYDE_DR	Location: SW
ADA ID: BEB4671E9127	Ramp Type: Perp	Initial Pass/Fail: Fail	Overall Compliance: No
		Severity Score: 22.5

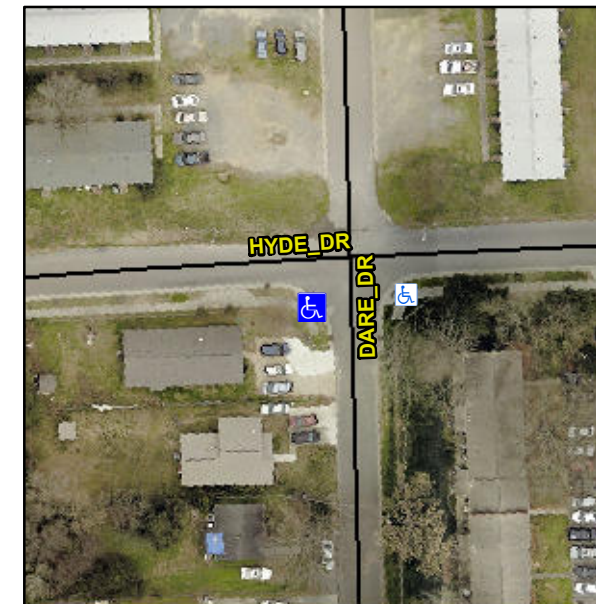
**Not Found, R304.5.1, R304.2.2, R304.5.3**

Compliance	Description	Data	Compliance	Description	Data
N/A	Ramp Length (in)	58.5	No	Ramp Slope (%)	9.7
No	Ramp Width (in)	47.0	No	Ramp XSlope (%)	2.3
N/A	Flare Type LT	N/A	N/A	Flare Type RT	N/A
N/A	Flare Slope LT (%)	N/A	N/A	Flare Slope RT (%)	N/A
N/A	Flare Traversable LT?	N/A	N/A	Flare Traversable RT?	N/A
N/A	Landing Length (in)	N/A	N/A	DWS Provided?	N/A
N/A	Landing Width (in)	N/A	N/A	DWS Contrast?	N/A
N/A	Landing Slope (%)	N/A	N/A	DWS Length (in)	N/A
N/A	Landing X Slope (%)	N/A	N/A	DWS Full Width?	N/A
N/A	Landing Curb? (Y/N)	N/A	N/A	DWS Offset (in)	N/A
N/A	Shared Landing?	N/A			
N/A	Gutter Ponding?	N/A	N/A	Gutter Slope (%)	N/A
N/A	Gutter Lip Ht (in)	N/A	N/A	Gutter X Slope (%)	N/A
N/A	Painted X Walk1?	No	N/A	Painted X Walk2?	N/A
	X Walk 1 Direction	To E		X Walk 2 Direction	N/A
N/A	X Walk 1 Width (in)	N/A	N/A	X Walk 2 Width (in)	N/A
	X Walk 1 Slope (%)	0.6		X Walk 2 Slope (%)	N/A
	X Walk 1 X Slope (%)	1.0		X Walk 2 X Slope (%)	N/A

N/A	Ramp inside XWalk1?	N/A	N/A	Ramp inside XWalk2?	N/A
	Road Slope (%)	N/A	N/A	Clear Space?	N/A
	Road X Slope (%)	N/A	N/A	Clear Space to XWalk (in)	N/A
N/A	Any Obstructions?	N/A	N/A	Storm Grate/Utility Hazard?	N/A
	Obstruction Type			Storm Grate/Utility Type	
		N/A			N/A
			Yes	Surface Condition? (G/P)	Good

**Remove & Replace Entire Ramp.**

Total Cost: \$ 1850.00
