Access Compliance Report

Public Rights-of-Way

(Curb Ramps)

Intersection ID: 12895	Main Street: ARNOLD_DR	Cross Street: GRAYBARK_AV	Location: SE
ADA ID: BEB6CB705BA7	Ramp Type: Para	Initial Pass/Fail: Fail	Overall Compliance: No
Codes/Mitigation Info/Possible Solution			Severity Score: 35
			Field Measurements/Component Compliance

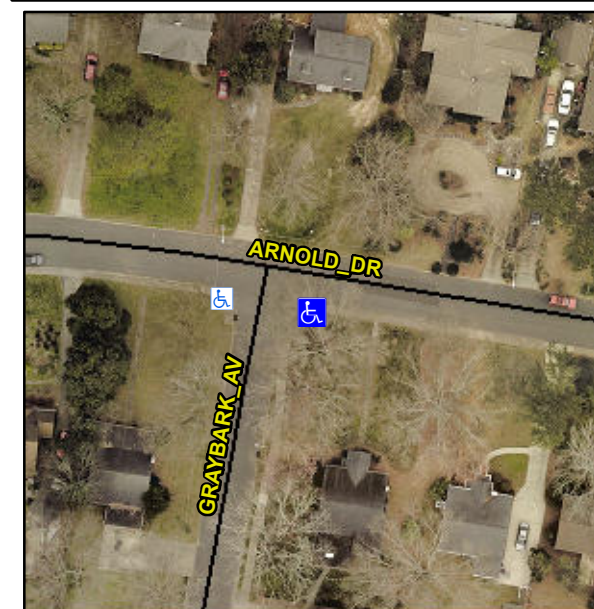
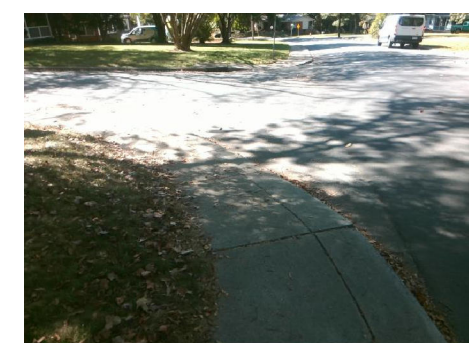
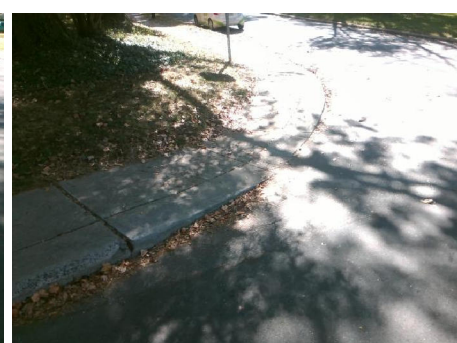
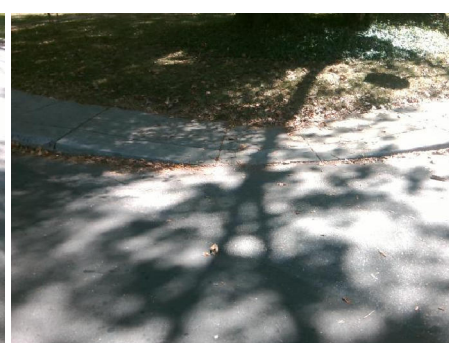
RT RP < 5%

R304.5.1, R304.3.2, R304.5.3

Compliance	Description	Data	Compliance	Description	Data
N/A	Ramp Length LT (in)	67.0	N/A	Ramp Length RT (in)	60.0
No	Ramp Width LT (in)	40.0	No	Ramp Width RT (in)	40.0
No	Ramp Slope LT (%)	12.6	Yes	Ramp Slope RT (%)	4.4
No	Ramp XSlope LT (%)	3.6	Yes	Ramp XSlope RT (%)	0.1
N/A	Landing Length (in)	N/A	N/A	DWS Provided?	N/A
N/A	Landing Width (in)	N/A	N/A	DWS Contrast?	N/A
N/A	Landing Slope (%)	N/A	N/A	DWS Length (in)	N/A
N/A	Landing X Slope (%)	N/A	N/A	DWS Full Width?	N/A
N/A	Landing Curb? (Y/N)	N/A	N/A	DWS Offset (in)	N/A
N/A	Shared Landing?	N/A			
N/A	Gutter Ponding?	N/A	N/A	Gutter Slope (%)	N/A
N/A	Gutter Lip Ht (in)	N/A	N/A	Gutter X Slope (%)	N/A
N/A	Painted X Walk1?	No	N/A	Painted X Walk2?	N/A
	X Walk 1 Direction	To W		X Walk 2 Direction	N/A
N/A	X Walk 1 Width (in)	N/A	N/A	X Walk 2 Width (in)	N/A
	X Walk 1 Slope (%)	2.9		X Walk 2 Slope (%)	N/A
	X Walk 1 X Slope (%)	2.6		X Walk 2 X Slope (%)	N/A
N/A	Ramp inside XWalk1?	N/A	N/A	Ramp inside XWalk2?	N/A

Road Slope (%)	N/A	N/A	Clear Space?	N/A
	Road X Slope (%)	N/A	N/A	Clear Space to XWalk (in)	N/A
N/A	Any Obstructions?	N/A	N/A	Storm Grate/Utility Hazard?	N/A
	Obstruction Type			Storm Grate/Utility Type	
		N/A			N/A
			Yes	Surface Condition? (G/P)	Good
			N/A	Curb Slope (%)	6.2

Possible Solutions:

Remove & Replace Entire Ramp.

Total Cost: \$ 1600.00
