# Access Compliance Report

## Public Rights-of-Way

### (Curb Ramps)

| ADA ID: BEBA0A6704EA | Ramp Type: Directional1 | Initial Pass/Fail: Fail | Overall Compliance: No |

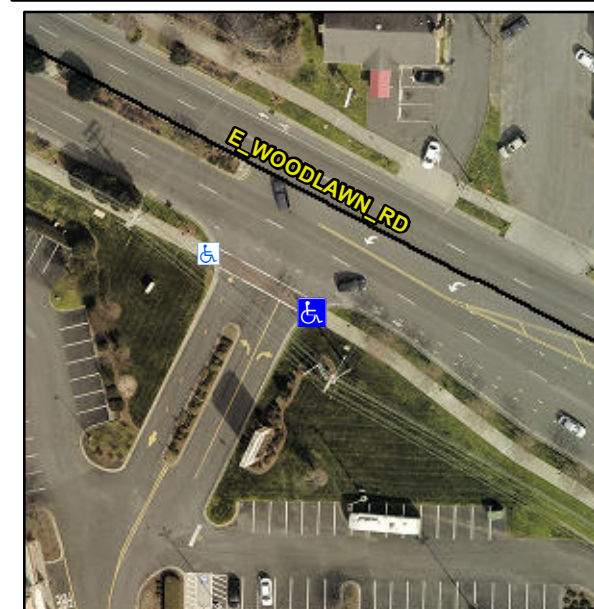
**R304.5.3**

| Compliance | Description | Data | Compliance | Description | Data |
|---|---|---|---|---|---|
| No | Ramp XSlope (%) | 2.5 | | | |

**Remove & Replace Entire Ramp.**
