Access Compliance Report

Public Rights-of-Way

(Curb Ramps)

Intersection ID: 10025447	Main Street: E_INDEPENDENCE_BV	Cross Street: N/A	Location: S
ADA ID: BEC2B9676D92	Ramp Type: Perp	Initial Pass/Fail: Pass	Overall Compliance: No
			Severity Score: 0

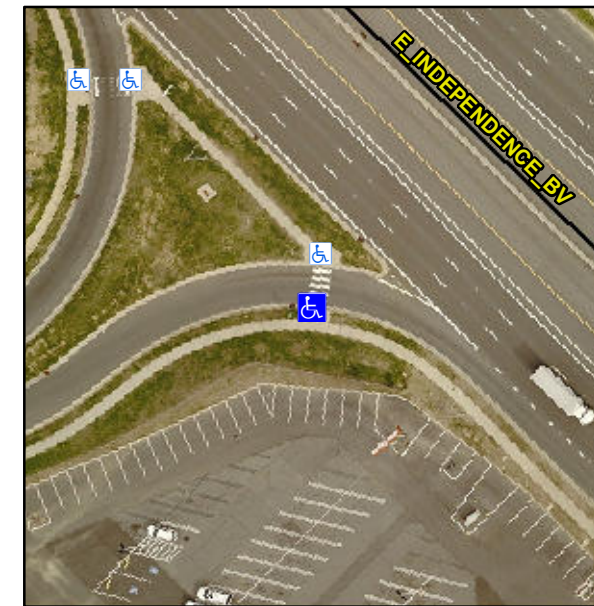
Compliance	Description	Data	Compliance	Description	Data
N/A	Ramp Length (in)	65.0	Yes	Ramp Slope (%)	8.2
Yes	Ramp Width (in)	60.0	Yes	Ramp XSlope (%)	1.6
N/A	Flare Type LT	Sloped	N/A	Flare Type RT	N/A
N/A	Flare Slope LT (%)	6.3	Yes	Flare Slope RT (%)	5.4
N/A	Flare Traversable LT?	Yes	N/A	Flare Traversable RT?	Yes
Yes	Landing Length (in)	70.0	Yes	DWS Provided?	Yes
Yes	Landing Width (in)	60.0	Yes	DWS Contrast?	Yes
Yes	Landing Slope (%)	1.5	Yes	DWS Length (in)	24.0
Yes	Landing X Slope (%)	0.8	Yes	DWS Full Width?	Yes
N/A	Landing Curb? (Y/N)	No	Yes	DWS Offset (in)	0.0
N/A	Shared Landing?	No			
Yes	Gutter Ponding?	No	Yes	Gutter Slope (%)	1.0
Yes	Gutter Lip Ht (in)	0.0	Yes	Gutter X Slope (%)	0.0
N/A	Painted X Walk1?	Yes	N/A	Painted X Walk2?	N/A
	X Walk 1 Direction	To N		X Walk 2 Direction	N/A
N/A	X Walk 1 Width (in)	119.5	N/A	X Walk 2 Width (in)	N/A
	X Walk 1 Slope (%)	4.8		X Walk 2 Slope (%)	N/A
	X Walk 1 X Slope (%)	0.7		X Walk 2 X Slope (%)	N/A

Yes	Ramp inside XWalk1?	Yes	N/A	Ramp inside XWalk2?	N/A
	Road Slope (%)	N/A	N/A	Clear Space?	Yes
	Road X Slope (%)	N/A	N/A	Clear Space to XWalk (in)	N/A
Yes	Any Obstructions?	No	Yes	Storm Grate/Utility Hazard?	No
	Obstruction Type			Storm Grate/Utility Type	
		N/A			N/A
			Yes	Surface Condition? (G/P)	Good

Remove & Replace Entire Ramp.
