# Access Compliance Report

## Public Rights-of-Way

### (Curb Ramps)

Intersection ID: 10032247	Main Street: MOSS_RD	Cross Street: N/A	Location: W
ADA ID: BEC56930A829	Ramp Type: BlendTrans2	Initial Pass/Fail: Pass	Overall Compliance: No
Codes/Mitigation Info/Possible Solution		Field Measurements/Component Compliance	
Severity Score: 10

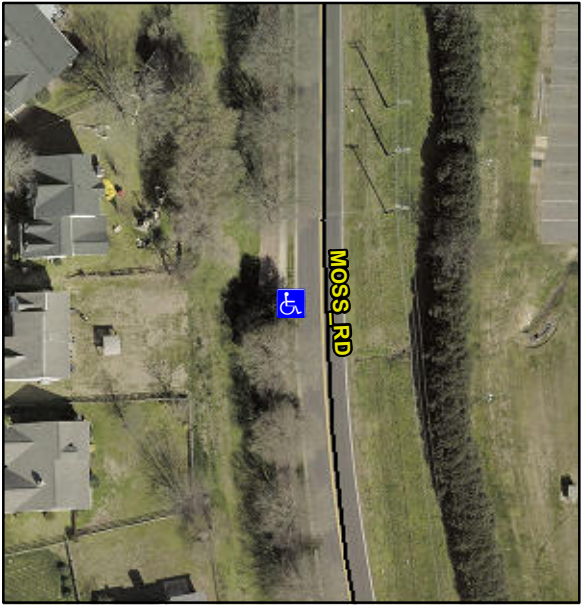
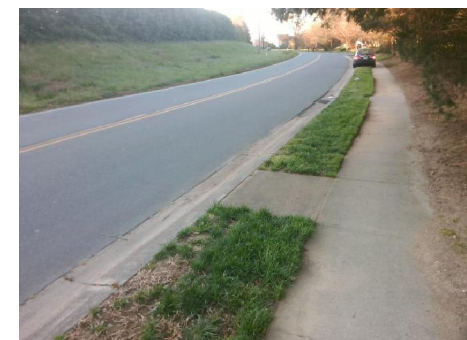
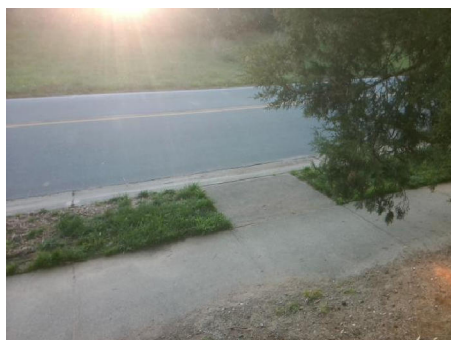
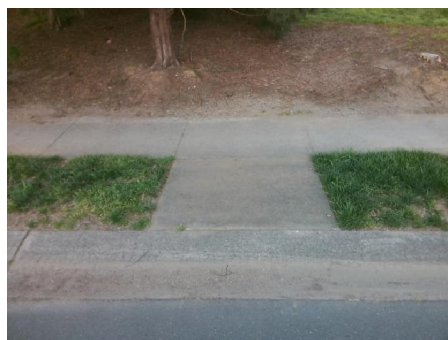
Possible Solutions:						
	Remove & Replace Curb Ramp With Two New Directional Ramps or Equivalent.	Compliance	Description	Data	Compliance	Description	Data
		N/A	Ramp Length (in)	97.0	Yes	BlendTrans Slope (%)	1.6
		Yes	Ramp Width (in)	60.0	Yes	BlendTrans XSlope (%)	0.1
		N/A	Flare Type LT	None	N/A	Flare Type RT	None
		N/A	Flare Slope LT (%)	N/A	N/A	Flare Slope RT (%)	N/A
		N/A	Flare Traversable LT?	N/A	N/A	Flare Traversable RT?	N/A
		N/A	Landing Length (in)	N/A	No	DWS Provided?	No
		N/A	Landing Width (in)	N/A	N/A	DWS Contrast?	No
		N/A	Landing Slope (%)	N/A	N/A	DWS Length (in)	N/A
<p>Surveyor Notes:</p> <p>N/A</p> <p>PROW/ADA:</p> <p>Not Found, R305</p>		N/A	Landing X Slope (%)	N/A	N/A	DWS Full Width?	No
		N/A	Landing Curb? (Y/N)	No	N/A	DWS Offset (in)	N/A
		N/A	Shared Landing?	No			
		Yes	Gutter Ponding?	No	Yes	Gutter Slope (%)	4.1
		Yes	Gutter Lip Ht (in)	0.0	Yes	Gutter X Slope (%)	1.3
		N/A	Painted X Walk1?	No	N/A	Painted X Walk2?	N/A

X Walk 1 Direction	To E		X Walk 2 Direction	N/A
			X Walk 1 Width (in)	N/A		X Walk 2 Width (in)	N/A
			X Walk 1 Slope (%)	4.8		X Walk 2 Slope (%)	N/A
			X Walk 1 X Slope (%)	0.2		X Walk 2 X Slope (%)	N/A
<p>Street 1 Name</p> <p>Stop Condition-Street 1</p> <p>Street 2 Name</p> <p>Stop Condition-Street 2</p>		N/A	Ramp inside XWalk1?	N/A	N/A	Ramp inside XWalk2?	N/A
			Road Slope (%)	0.2		Clear Space?	Yes
			Road X Slope (%)	4.8	N/A	Clear Space to XWalk (in)	N/A
		Yes	Any Obstructions?	No	Yes	Storm Grate/Utility Hazard?	No
			Obstruction Type			Storm Grate/Utility Type	
					N/A		N/A
					Yes	Surface Condition? (G/P)	Good
					No	Curb Slope (%)	34.0
Total Cost:		\$	3200.00
