Access Compliance Report

Public Rights-of-Way

(Curb Ramps)

Intersection ID: 18484	Main Street: FOXCROFT_WOODS_LN	Cross Street: SHARON_RD	Location: SW
ADA ID: BEC94CF13B39	Ramp Type: Directional1	Initial Pass/Fail: Fail	Overall Compliance: No
Severity Score: 26.25			
Codes/Mitigation Info/Possible Solution		Field Measurements/Component Compliance

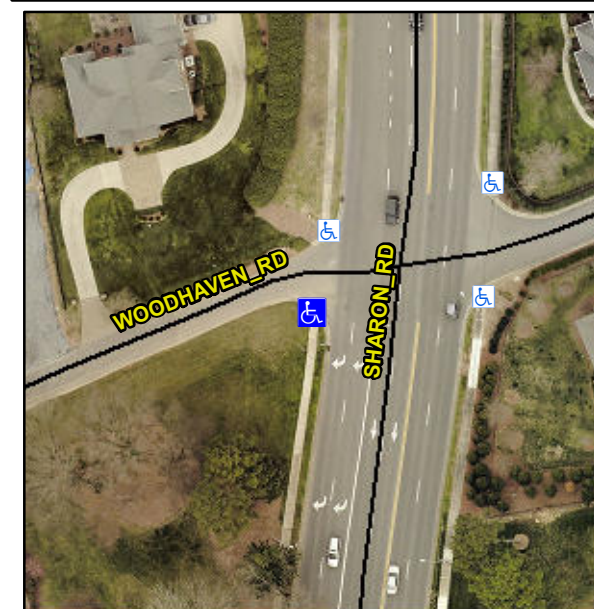
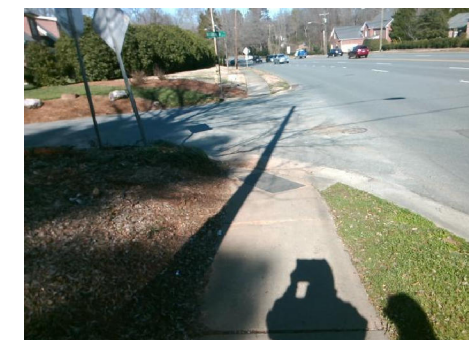
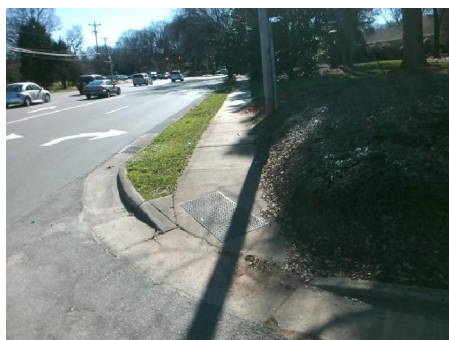
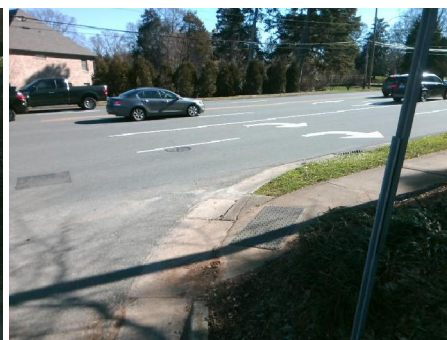
Compliance	Description	Data	Compliance	Description	Data
N/A	Ramp Length (in)	77.0	N/A	Grade Break?	N/A
Yes	Ramp Width (in)	51.0	N/A	Grade Break Slope (%)	0.0
No	Ramp Slope (%)	13.3	N/A	Grade Break XSlope (%)	0.0
No	Ramp XSlope (%)	4.5			
N/A	Flare Type LT	N/A	N/A	Flare Type RT	N/A
N/A	Flare Slope LT (%)	N/A	N/A	Flare Slope RT (%)	0.0
N/A	Flare Traversable LT?	N/A	N/A	Flare Traversable RT?	N/A
N/A	Landing Length (in)	0.0	N/A	DWS Provided?	N/A
N/A	Landing Width (in)	0.0	N/A	DWS Contrast?	N/A
N/A	Landing Slope (%)	0.0	N/A	DWS Length (in)	N/A
N/A	Landing X Slope (%)	0.0	N/A	DWS Full Width?	N/A
N/A	Landing Curb? (Y/N)	N/A	N/A	DWS Offset LT (in)	N/A
N/A	Shared Landing?	N/A	N/A	DWS Offset RT (in)	N/A
N/A	Gutter Ponding?	0.0	N/A	Gutter Slope (%)	N/A
N/A	Gutter Lip Ht (in)	0.0	N/A	Gutter X Slope (%)	N/A
N/A	Painted X Walk1?	No		Road Slope (%)	2.2
	X Walk 1 Direction	To N		Road X Slope (%)	0.2
	X Walk 1 Width (in)	N/A		Clear Space?	N/A

X Walk 1 Slope (%)	2.2	N/A	Clear Space to XWalk (in)	N/A
	X Walk 1 X Slope (%)	0.2	N/A	Storm Grate/Utility Hazard?	N/A
N/A	Ramp inside XWalk1?	N/A		Storm Grate/Utility Type	
N/A	Any Obstructions?	N/A			N/A
	Obstruction Type		Yes	Surface Condition? (G/P)	Good
			N/A	Curb Slope (%)	4.6

Possible Solutions:

Remove & Replace Entire Ramp.

R304.2.2, R304.5.3
