Access Compliance Report

Public Rights-of-Way

(Curb Ramps)

| Intersection ID: 46736 | Main Street: ROBINSON_MEADOW_CT | Cross Street: BEAVER_BROOK_WY | Location: E |

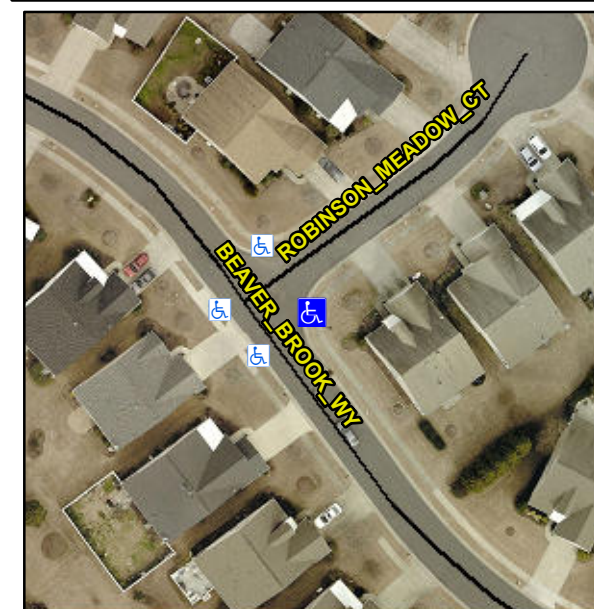
| ADA ID: BECF9DD86E01 | Ramp Type: BlendTrans1 | Initial Pass/Fail: Fail | Overall Compliance: No |
| Severity Score: 10 | | | |

Not Found, R304.5.1, R304.5.3

| Compliance | Description | Data | Compliance | Description | Data |
|---|---|---|---|---|---|
| No | Ramp Width (in) | 39.0 | No | BlendTrans XSlope (%) | 3.0 |

Remove & Replace Curb Ramp With Two New Directional Ramps or Equivalent.

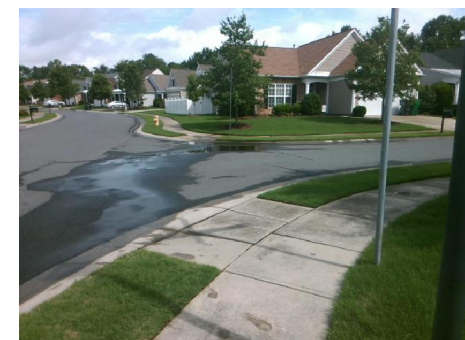
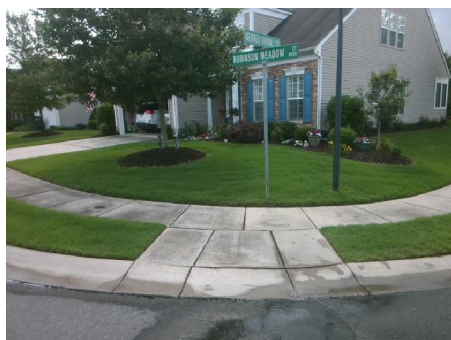
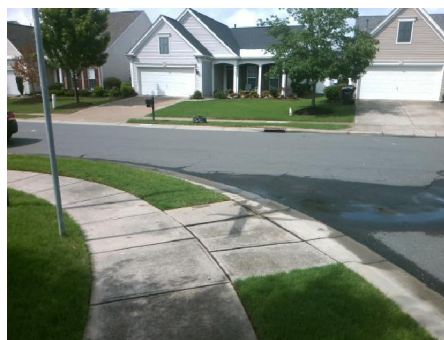
| Compliance | Description | Data | Compliance | Description | Data |
|---|---|---|---|---|---|
| | | | No | Curb Slope (%) | 8.0 |
