# Access Compliance Report

## Public Rights-of-Way

### (Curb Ramps)

Intersection ID: 6851	Main Street: ANDREW_WARD_AV	Cross Street: MARGARET_TURNER_RD	Location:	N
ADA ID: BED0C8CA6D9F	Ramp Type: BlendTrans2	Initial Pass/Fail: Fail	Overall Compliance: No	Severity Score: 25

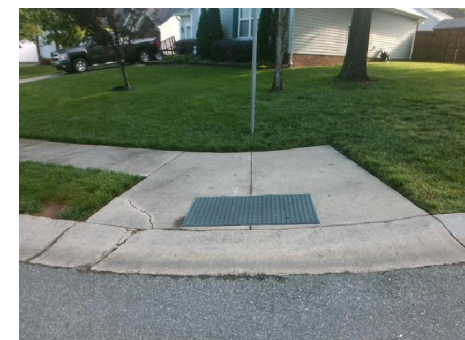
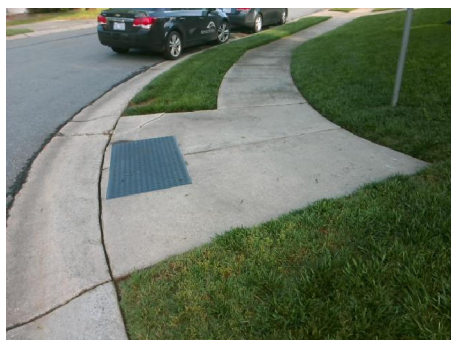
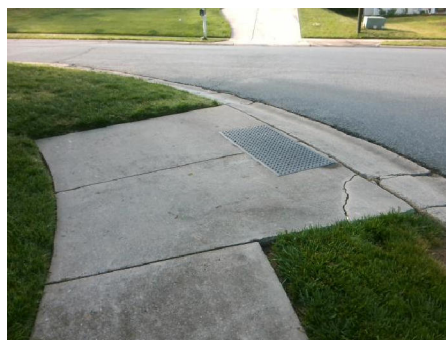
Possible Solutions:		Compliance	Description	Data	Compliance	Description	Data
	Remove & Replace Curb Ramp With Two New Directional Ramps or Equivalent.		N/A	Ramp Length (in)	96.0	Yes	BlendTrans Slope (%)	3.4
			Yes	Ramp Width (in)	89.0	No	BlendTrans XSlope (%)	8.9
			N/A	Flare Type LT	N/A	N/A	Flare Type RT	N/A
			N/A	Flare Slope LT (%)	N/A	N/A	Flare Slope RT (%)	N/A
			N/A	Flare Traversable LT?	N/A	N/A	Flare Traversable RT?	N/A
			N/A	Landing Length (in)	N/A	N/A	DWS Provided?	N/A
			N/A	Landing Width (in)	N/A	N/A	DWS Contrast?	N/A
			N/A	Landing Slope (%)	N/A	N/A	DWS Length (in)	N/A
			N/A	Landing X Slope (%)	N/A	N/A	DWS Full Width?	N/A
<p>Surveyor Notes:</p> <p>N/A</p> <p>PROW/ADA:</p> <p>Not Found, R304.5.3</p>			N/A	Landing Curb? (Y/N)	N/A	N/A	DWS Offset (in)	N/A
			N/A	Shared Landing?	N/A			
			N/A	Gutter Ponding?	N/A	N/A	Gutter Slope (%)	N/A

N/A	Gutter Lip Ht (in)	N/A	N/A	Gutter X Slope (%)	N/A
			N/A	Painted X Walk1?	No	N/A	Painted X Walk2?	N/A
				X Walk 1 Direction	To W		X Walk 2 Direction	N/A
				X Walk 1 Width (in)	N/A		X Walk 2 Width (in)	N/A
				X Walk 1 Slope (%)	1.8		X Walk 2 Slope (%)	N/A
				X Walk 1 X Slope (%)	5.7		X Walk 2 X Slope (%)	N/A
			N/A	Ramp inside XWalk1?	N/A	N/A	Ramp inside XWalk2?	N/A
			Road Slope (%)	5.7		Clear Space?	N/A	
			Road X Slope (%)	1.8	N/A	Clear Space to XWalk (in)	N/A	
		N/A	Any Obstructions?	N/A	N/A	Storm Grate/Utility Hazard?	N/A	
			Obstruction Type			Storm Grate/Utility Type		
					N/A			N/A
					Yes	Surface Condition? (G/P)	Good	
					No	Curb Slope (%)	5.7
