# Access Compliance Report

## Public Rights-of-Way

### (Curb Ramps)

Intersection ID: 48956	Main Street: JOSHUA_CAIN_RD	Cross Street: DAVID_JENNINGS_AV	Location:	N
ADA ID: BEDFF8B5BD5B	Ramp Type: Perp	Initial Pass/Fail: Fail	Overall Compliance: No	Severity Score: 12.5
Codes/Mitigation Info/Possible Solution		Field Measurements/Component Compliance

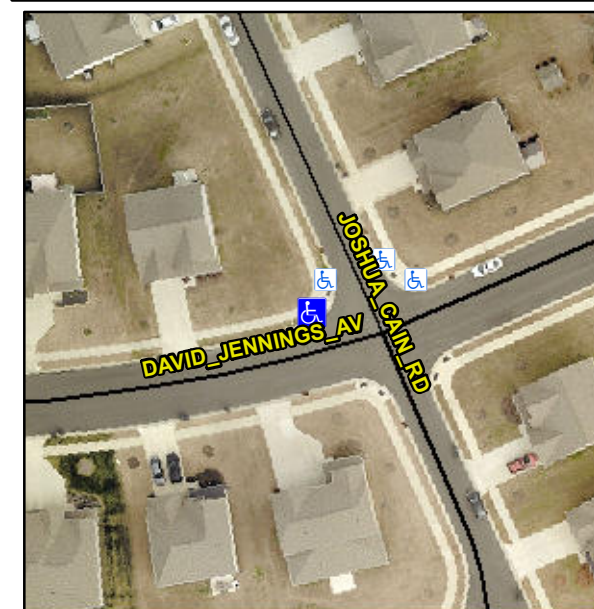
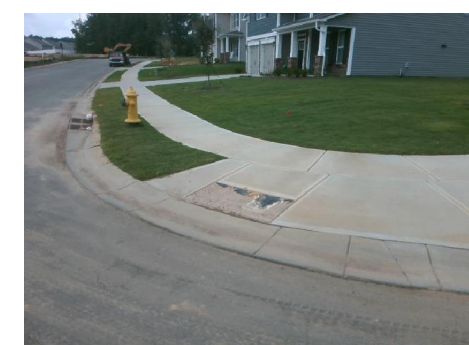
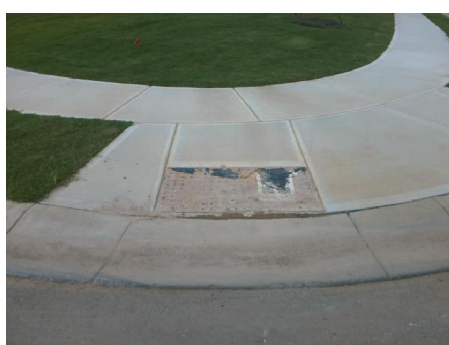
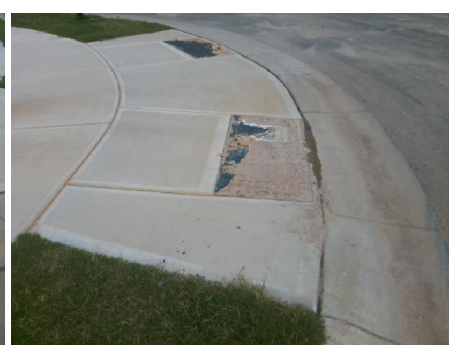
**Not Found, R304.2.2**

Compliance	Description	Data	Compliance	Description	Data
N/A	Ramp Length (in)	63.0	No	Ramp Slope (%)	8.6
Yes	Ramp Width (in)	48.0	Yes	Ramp XSlope (%)	0.2
N/A	Flare Type LT	N/A	N/A	Flare Type RT	N/A
N/A	Flare Slope LT (%)	N/A	N/A	Flare Slope RT (%)	N/A
N/A	Flare Traversable LT?	N/A	N/A	Flare Traversable RT?	N/A
N/A	Landing Length (in)	N/A	N/A	DWS Provided?	N/A
N/A	Landing Width (in)	N/A	N/A	DWS Contrast?	N/A
N/A	Landing Slope (%)	N/A	N/A	DWS Length (in)	N/A
N/A	Landing X Slope (%)	N/A	N/A	DWS Full Width?	N/A
N/A	Landing Curb? (Y/N)	N/A	N/A	DWS Offset (in)	N/A
N/A	Shared Landing?	N/A			
N/A	Gutter Ponding?	N/A	N/A	Gutter Slope (%)	N/A
N/A	Gutter Lip Ht (in)	1.0	N/A	Gutter X Slope (%)	N/A
N/A	Painted X Walk1?	No	N/A	Painted X Walk2?	N/A
	X Walk 1 Direction	To S		X Walk 2 Direction	N/A
N/A	X Walk 1 Width (in)	N/A	N/A	X Walk 2 Width (in)	N/A
	X Walk 1 Slope (%)	5.2		X Walk 2 Slope (%)	N/A
	X Walk 1 X Slope (%)	2.6		X Walk 2 X Slope (%)	N/A

N/A	Ramp inside XWalk1?	N/A	N/A	Ramp inside XWalk2?	N/A
	Road Slope (%)	2.6	N/A	Clear Space?	N/A
	Road X Slope (%)	5.2	N/A	Clear Space to XWalk (in)	N/A
N/A	Any Obstructions?	N/A	N/A	Storm Grate/Utility Hazard?	N/A
	Obstruction Type			Storm Grate/Utility Type	
		N/A			N/A
			Yes	Surface Condition? (G/P)	Good

**Remove & Replace Entire Ramp.**

Total Cost: \$ 1850.00
