Access Compliance Report

Public Rights-of-Way

(Curb Ramps)

Intersection ID: 10024504	Main Street: CRUMP_RD	Cross Street: N/A	Location: W
ADA ID: BEE4B5E7855A	Ramp Type: Perp	Initial Pass/Fail: Fail	Overall Compliance: No
			Severity Score: 21.25

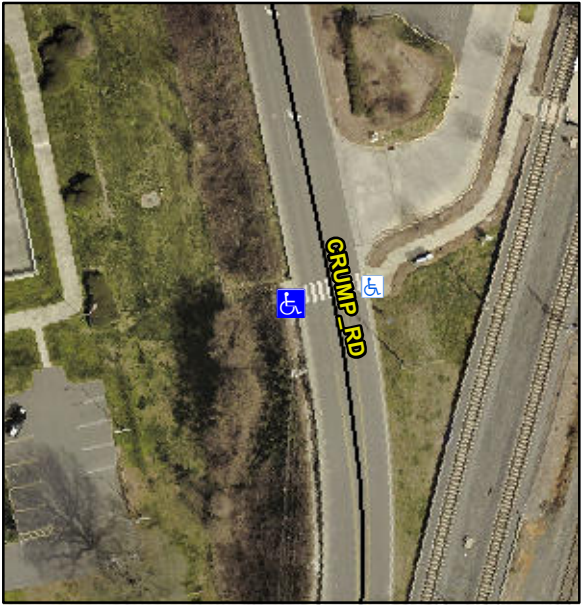
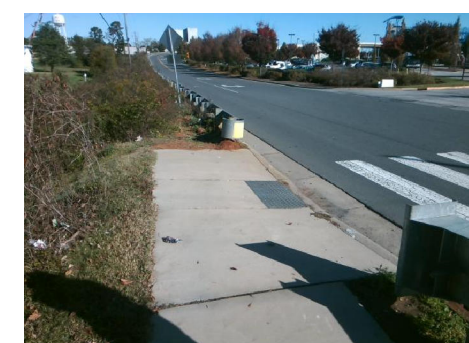
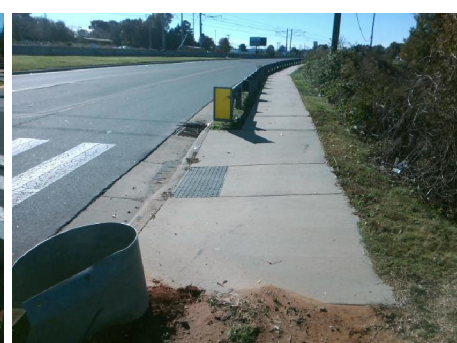
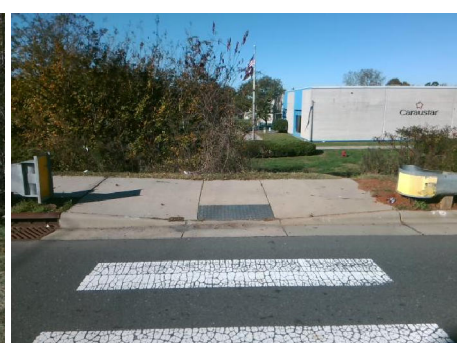
Possible Solutions:		Compliance	Description	Data
	Remove & Replace Entire Ramp.		N/A	Ramp Length (in)	82.0
			No	Ramp Width (in)	46.5
			N/A	Flare Type LT	N/A
			N/A	Flare Slope LT (%)	N/A
			N/A	Flare Traversable LT?	N/A
			N/A	Landing Length (in)	N/A
			N/A	Landing Width (in)	N/A
			N/A	Landing Slope (%)	N/A
			N/A	Landing X Slope (%)	N/A
			N/A	Landing Curb? (Y/N)	N/A
			N/A	Shared Landing?	N/A
			N/A	Gutter Ponding?	N/A
			N/A	Gutter Lip Ht (in)	N/A
			N/A	Painted X Walk1?	Yes
				X Walk 1 Direction	To E
			N/A	X Walk 1 Width (in)	120.0
				X Walk 1 Slope (%)	1.4
				X Walk 1 X Slope (%)	0.7
			N/A	Ramp inside XWalk1?	Yes
<p>Surveyor Notes:</p> <p>N/A</p> <p>PROW/ADA:</p> <p>R304.5.1, R304.2.2</p>			N/A	Flare Type RT	N/A
			N/A	Flare Slope RT (%)	N/A
			N/A	Flare Traversable RT?	N/A
			N/A	DWS Provided?	N/A
			N/A	DWS Contrast?	N/A

N/A	DWS Length (in)	N/A
			N/A	DWS Full Width?	N/A
			N/A	DWS Offset (in)	N/A
			N/A	Gutter Slope (%)	N/A
			N/A	Gutter X Slope (%)	N/A
			N/A	Painted X Walk2?	N/A
				X Walk 2 Direction	N/A
			N/A	X Walk 2 Width (in)	N/A
				X Walk 2 Slope (%)	N/A
				X Walk 2 X Slope (%)	N/A
			N/A	Ramp inside XWalk2?	N/A
			N/A	Clear Space?	N/A
			N/A	Clear Space to XWalk (in)	N/A
			N/A	Storm Grate/Utility Hazard?	N/A
				Storm Grate/Utility Type	N/A
<p>Total Cost:</p> <p>\$ 1850.00</p>			N/A		N/A
			Yes	Surface Condition? (G/P)	Good
