Access Compliance Report

Public Rights-of-Way

(Curb Ramps)

Intersection ID: 8727	Main Street: NEWLAND_RD	Cross Street: SAMUEL_ST	Location: S
ADA ID: BEEB7AA29851	Ramp Type: Perp	Initial Pass/Fail: Fail	Overall Compliance: No
Severity Score: 12.5			
Codes/Mitigation Info/Possible Solution		Field Measurements/Component Compliance

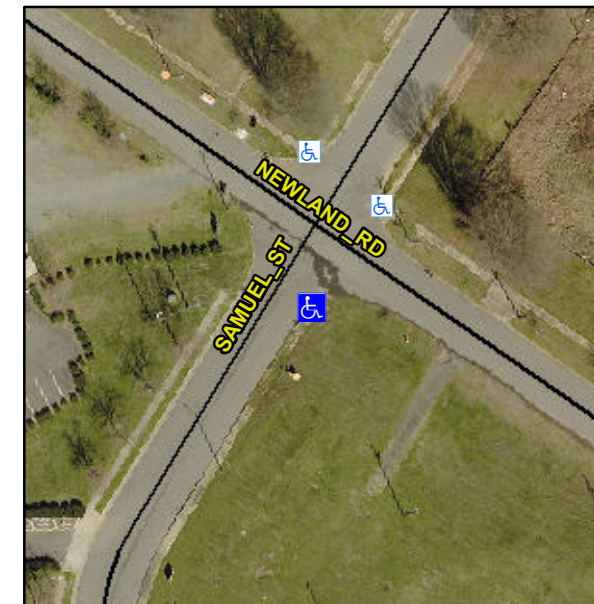
Not Found, R304.2.2

Compliance	Description	Data	Compliance	Description	Data
N/A	Ramp Length (in)	60.0	No	Ramp Slope (%)	9.9
Yes	Ramp Width (in)	48.0	Yes	Ramp XSlope (%)	0.4
N/A	Flare Type LT	N/A	N/A	Flare Type RT	N/A
N/A	Flare Slope LT (%)	N/A	N/A	Flare Slope RT (%)	N/A
N/A	Flare Traversable LT?	N/A	N/A	Flare Traversable RT?	N/A
N/A	Landing Length (in)	N/A	N/A	DWS Provided?	N/A
N/A	Landing Width (in)	N/A	N/A	DWS Contrast?	N/A
N/A	Landing Slope (%)	N/A	N/A	DWS Length (in)	N/A
N/A	Landing X Slope (%)	N/A	N/A	DWS Full Width?	N/A
N/A	Landing Curb? (Y/N)	N/A	N/A	DWS Offset (in)	N/A
N/A	Shared Landing?	N/A			
N/A	Gutter Ponding?	N/A	N/A	Gutter Slope (%)	N/A
N/A	Gutter Lip Ht (in)	N/A	N/A	Gutter X Slope (%)	N/A
N/A	Painted X Walk1?	No	N/A	Painted X Walk2?	N/A
	X Walk 1 Direction	To NE		X Walk 2 Direction	N/A
N/A	X Walk 1 Width (in)	N/A	N/A	X Walk 2 Width (in)	N/A
	X Walk 1 Slope (%)	1.6		X Walk 2 Slope (%)	N/A
	X Walk 1 X Slope (%)	0.4		X Walk 2 X Slope (%)	N/A

N/A	Ramp inside XWalk1?	N/A	N/A	Ramp inside XWalk2?	N/A
	Road Slope (%)	N/A	N/A	Clear Space?	N/A
	Road X Slope (%)	N/A	N/A	Clear Space to XWalk (in)	N/A
N/A	Any Obstructions?	N/A	N/A	Storm Grate/Utility Hazard?	N/A
	Obstruction Type			Storm Grate/Utility Type	
		N/A			N/A
		Yes		Surface Condition? (G/P)	Good

Possible Solutions:

Remove & Replace Entire Ramp.
