Access Compliance Report

Public Rights-of-Way

(Curb Ramps)

Intersection ID: 15657	Main Street: CUMBERLAND_AV	Cross Street: LYNWAY_DR	Location:	N
ADA ID: BEED3A0ED86A	Ramp Type: PerpDiag	Initial Pass/Fail: Fail	Overall Compliance: No	Severity Score: 25
Codes/Mitigation Info/Possible Solution		Field Measurements/Component Compliance

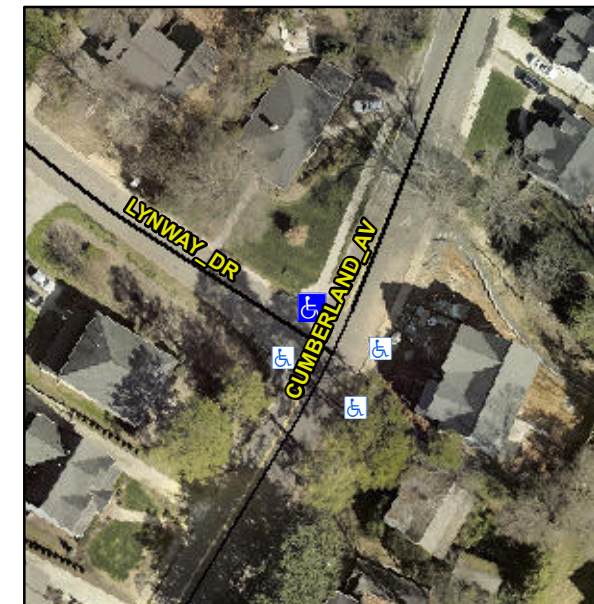
Not Found, R304.2.2, R304.5.3

Compliance	Description	Data	Compliance	Description	Data
N/A	Ramp Length (in)	79.0	No	Ramp Slope (%)	8.7
Yes	Ramp Width (in)	48.0	No	Ramp XSlope (%)	5.9
N/A	Flare Type LT	N/A	N/A	Flare Type RT	N/A
N/A	Flare Slope LT (%)	N/A	N/A	Flare Slope RT (%)	N/A
N/A	Flare Traversable LT?	N/A	N/A	Flare Traversable RT?	N/A
N/A	Landing Length (in)	N/A	N/A	DWS Provided?	N/A
N/A	Landing Width (in)	N/A	N/A	DWS Contrast?	N/A
N/A	Landing Slope (%)	N/A	N/A	DWS Length (in)	N/A
N/A	Landing X Slope (%)	N/A	N/A	DWS Full Width?	N/A
N/A	Landing Curb? (Y/N)	N/A	N/A	DWS Offset (in)	N/A
N/A	Shared Landing?	N/A			
N/A	Gutter Ponding?	N/A	N/A	Gutter Slope (%)	N/A
N/A	Gutter Lip Ht (in)	N/A	N/A	Gutter X Slope (%)	N/A
N/A	Painted X Walk1?	No	N/A	Painted X Walk2?	No
	X Walk 1 Direction	To SW		X Walk 2 Direction	To SE
N/A	X Walk 1 Width (in)	N/A	N/A	X Walk 2 Width (in)	N/A
	X Walk 1 Slope (%)	8.0		X Walk 2 Slope (%)	1.6
	X Walk 1 X Slope (%)	1.5		X Walk 2 X Slope (%)	6.4

N/A	Ramp inside XWalk1?	N/A	N/A	Ramp inside XWalk2?	N/A
	Road Slope (%)	5.2	N/A	Clear Space?	N/A
	Road X Slope (%)	8.1	N/A	Clear Space to XWalk (in)	N/A
N/A	Any Obstructions?	N/A	N/A	Storm Grate/Utility Hazard?	N/A
	Obstruction Type			Storm Grate/Utility Type	
		N/A			N/A
			Yes	Surface Condition? (G/P)	Good

Possible Solutions:

Remove & Replace Curb Ramp With Two New Directional Ramps or Equivalent.
