Access Compliance Report

Public Rights-of-Way

(Curb Ramps)

Intersection ID: 11690	Main Street: AIRLIE_ST	Cross Street: JEFF_ST	Location: SE
ADA ID: BEED82B455E4	Ramp Type: BlendTrans1	Initial Pass/Fail: Fail	Overall Compliance: No
Codes/Mitigation Info/Possible Solution		Field Measurements/Component Compliance	
Severity Score: 8.75

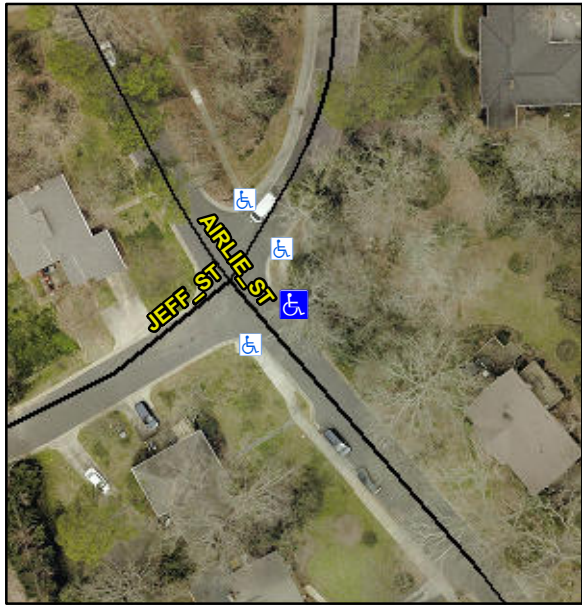
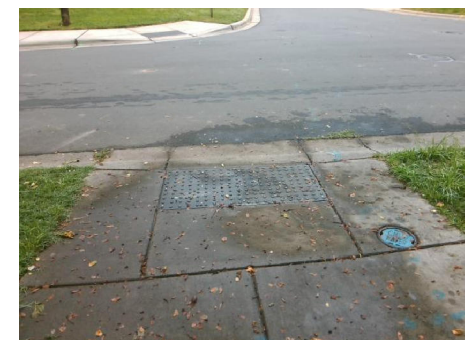
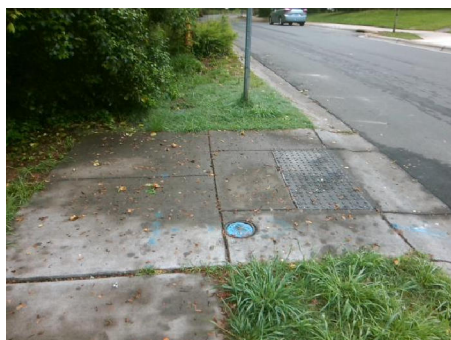
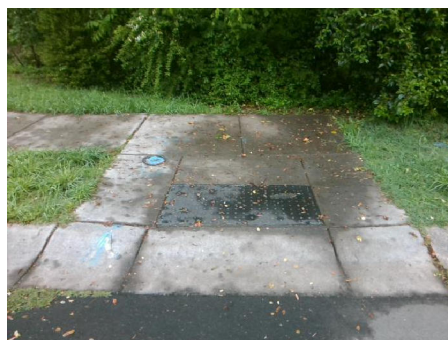
Not Found, R304.5.1

Compliance	Description	Data	Compliance	Description	Data
N/A	Ramp Length (in)	48.0	Yes	BlendTrans Slope (%)	2.6
No	Ramp Width (in)	47.5	Yes	BlendTrans XSlope (%)	2.0
N/A	Flare Type LT	N/A	N/A	Flare Type RT	N/A
N/A	Flare Slope LT (%)	N/A	N/A	Flare Slope RT (%)	N/A
N/A	Flare Traversable LT?	N/A	N/A	Flare Traversable RT?	N/A
N/A	Landing Length (in)	N/A	N/A	DWS Provided?	N/A
N/A	Landing Width (in)	N/A	N/A	DWS Contrast?	N/A
N/A	Landing Slope (%)	N/A	N/A	DWS Length (in)	N/A
N/A	Landing X Slope (%)	N/A	N/A	DWS Full Width?	N/A
N/A	Landing Curb? (Y/N)	N/A	N/A	DWS Offset (in)	N/A
N/A	Shared Landing?	N/A			
N/A	Gutter Ponding?	N/A	N/A	Gutter Slope (%)	N/A
N/A	Gutter Lip Ht (in)	N/A	N/A	Gutter X Slope (%)	N/A
N/A	Painted X Walk1?	No	N/A	Painted X Walk2?	N/A
	X Walk 1 Direction	To SW		X Walk 2 Direction	N/A
	X Walk 1 Width (in)	N/A		X Walk 2 Width (in)	N/A
	X Walk 1 Slope (%)	4.0		X Walk 2 Slope (%)	N/A
	X Walk 1 X Slope (%)	2.5		X Walk 2 X Slope (%)	N/A

N/A	Ramp inside XWalk1?	N/A	N/A	Ramp inside XWalk2?	N/A
	Road Slope (%)	2.5		Clear Space?	N/A
	Road X Slope (%)	4.0	N/A	Clear Space to XWalk (in)	N/A
N/A	Any Obstructions?	N/A	N/A	Storm Grate/Utility Hazard?	N/A
	Obstruction Type			Storm Grate/Utility Type	
		N/A			N/A
			Yes	Surface Condition? (G/P)	Good
			No	Curb Slope (%)	19.8

Remove & Replace Curb Ramp With Two New Directional Ramps or Equivalent.
