# Access Compliance Report

## Public Rights-of-Way

### (Curb Ramps)

Intersection ID: 5314	Main Street: PAVILION_BV	Cross Street: WHEATSIDE_DR	Location: SE
ADA ID: BEEDE52FD380	Ramp Type: Perp	Initial Pass/Fail: Fail	Overall Compliance: No
Severity Score: 21.25			
Codes/Mitigation Info/Possible Solution		Field Measurements/Component Compliance

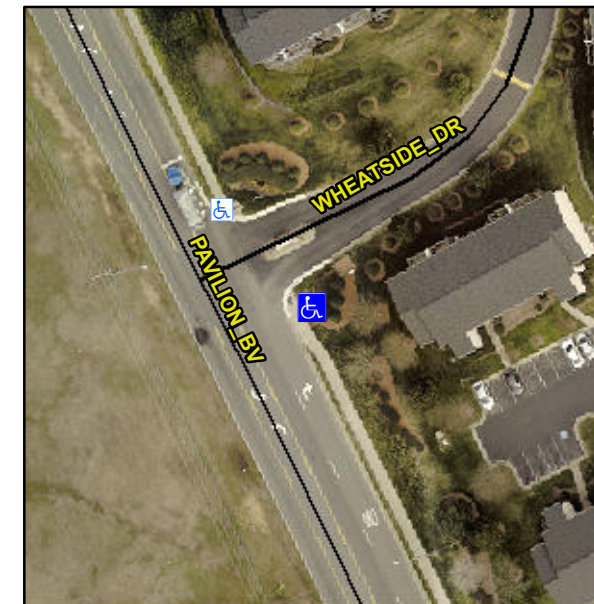
Compliance	Description	Data	Compliance	Description	Data
N/A	Ramp Length (in)	44.0	Yes	Ramp Slope (%)	5.0
No	Ramp Width (in)	47.5	No	Ramp XSlope (%)	5.4
N/A	Flare Type LT	N/A	N/A	Flare Type RT	N/A
N/A	Flare Slope LT (%)	N/A	N/A	Flare Slope RT (%)	N/A
N/A	Flare Traversable LT?	N/A	N/A	Flare Traversable RT?	N/A
N/A	Landing Length (in)	N/A	N/A	DWS Provided?	N/A
N/A	Landing Width (in)	N/A	N/A	DWS Contrast?	N/A
N/A	Landing Slope (%)	N/A	N/A	DWS Length (in)	N/A
N/A	Landing X Slope (%)	N/A	N/A	DWS Full Width?	N/A
N/A	Landing Curb? (Y/N)	N/A	N/A	DWS Offset (in)	N/A
N/A	Shared Landing?	N/A			
N/A	Gutter Ponding?	N/A	N/A	Gutter Slope (%)	N/A
N/A	Gutter Lip Ht (in)	N/A	N/A	Gutter X Slope (%)	N/A
N/A	Painted X Walk1?	No	N/A	Painted X Walk2?	N/A
	X Walk 1 Direction	To NW		X Walk 2 Direction	N/A
N/A	X Walk 1 Width (in)	N/A	N/A	X Walk 2 Width (in)	N/A
	X Walk 1 Slope (%)	0.9		X Walk 2 Slope (%)	N/A
	X Walk 1 X Slope (%)	3.4		X Walk 2 X Slope (%)	N/A

N/A	Ramp inside XWalk1?	N/A	N/A	Ramp inside XWalk2?	N/A
	Road Slope (%)	N/A	N/A	Clear Space?	N/A
	Road X Slope (%)	N/A	N/A	Clear Space to XWalk (in)	N/A
N/A	Any Obstructions?	N/A	N/A	Storm Grate/Utility Hazard?	N/A
	Obstruction Type			Storm Grate/Utility Type	
		N/A			N/A
		Yes		Surface Condition? (G/P)	Good

**Remove & Replace Entire Ramp.**

**R304.5.1, R304.5.3**
