Access Compliance Report

Public Rights-of-Way

(Curb Ramps)

Intersection ID: 10038412	Main Street: SOUTH_POINT_BV	Cross Street: N/A	Location:	E
ADA ID: BEF6930F3A16	Ramp Type: Combination1	Initial Pass/Fail: Fail	Overall Compliance: No	Severity Score: 25

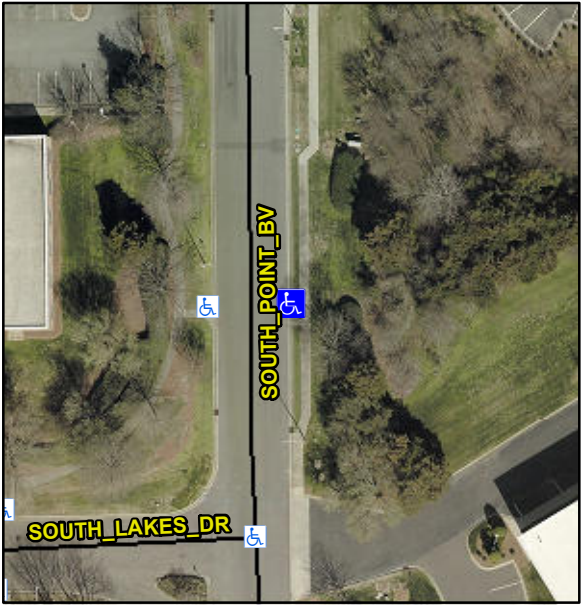
Possible Solutions:		Compliance	Description	Data	
	Remove & Replace Entire Ramp.		N/A	Ramp Length LT (in)	72.0	
			Yes	Ramp Width LT (in)	59.0	
			Yes	Ramp Slope LT (%)	7.6	
			No	Ramp XSlope LT (%)	3.1	
			N/A	Ramp Length (in)	49.0	
			Yes	Ramp Width (in)	48.0	
	Surveyor Notes:		N/A	Flare Type LT	N/A	
	RT RP < 5%		N/A	Flare Slope LT (%)	N/A	
			N/A	Flare Traversable LT?	N/A	
			N/A	Landing Length (in)	N/A	
			N/A	Landing Width (in)	N/A	
			N/A	Landing Slope (%)	N/A	
			N/A	Landing X Slope (%)	N/A	
			N/A	Landing Curb? (Y/N)	N/A	
			N/A	Shared Landing?	N/A	
			N/A	Gutter Ponding?	N/A	
			N/A	Gutter Lip Ht (in)	N/A	
			N/A	Painted X Walk1?	No	
				X Walk 1 Direction	To W	
				X Walk 1 Width (in)	N/A	
				X Walk 1 Slope (%)	5.8	
				X Walk 1 X Slope (%)	3.4

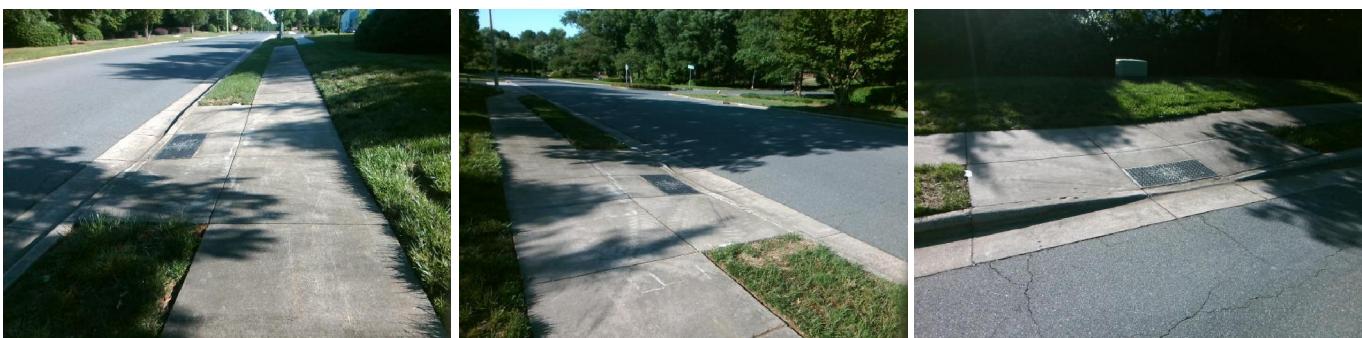
PROW/ADA:		N/A	Ramp inside XWalk1?	N/A	
	R304.2.2, R304.5.3			Road Slope (%)	N/A
