Access Compliance Report

Public Rights-of-Way

(Curb Ramps)

Intersection ID: 7668	Main Street: STONEFACE_RD	Cross Street: SULLINS_RD	Location: S
ADA ID: BEFADEC39957	Ramp Type: Perp	Initial Pass/Fail: Fail	Overall Compliance: No
		Severity Score: 8.75

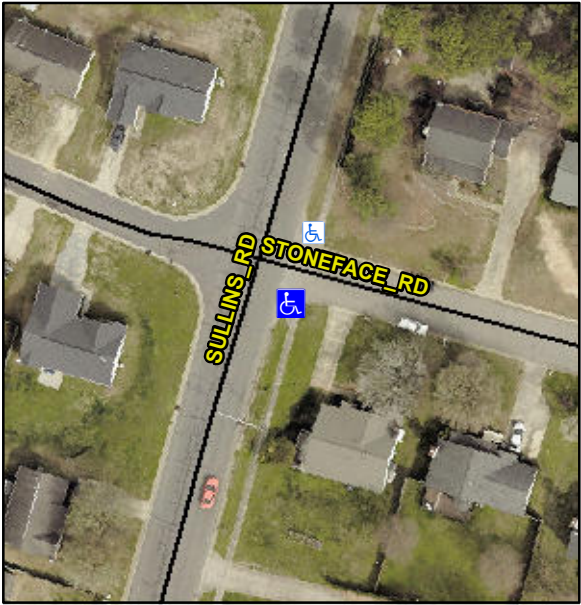
Possible Solutions:		Compliance	Description	Data
	Remove & Replace Entire Ramp.		N/A	Ramp Length (in)	62.0
			No	Ramp Width (in)	41.0
			N/A	Flare Type LT	N/A
			N/A	Flare Slope LT (%)	N/A
			N/A	Flare Traversable LT?	N/A
			N/A	Landing Length (in)	N/A
			N/A	Landing Width (in)	N/A
			N/A	Landing Slope (%)	N/A
			N/A	Landing X Slope (%)	N/A
<p>Surveyor Notes:</p> <p>N/A</p> <p>PROW/ADA:</p> <p>Not Found, R304.5.1</p>			N/A	Flare Type RT	N/A
			N/A	Flare Slope RT (%)	N/A
			N/A	Flare Traversable RT?	N/A
			N/A	DWS Provided?	N/A
			N/A	DWS Contrast?	N/A
			N/A	DWS Length (in)	N/A
			N/A	DWS Full Width?	N/A
			N/A	DWS Offset (in)	N/A
			N/A	Shared Landing?	N/A
			N/A	Gutter Ponding?	N/A
			N/A	Gutter Lip Ht (in)	0.5
			N/A	Painted X Walk1?	No
				X Walk 1 Direction	To N
			N/A	X Walk 1 Width (in)	N/A
				X Walk 1 Slope (%)	4.5
				X Walk 1 X Slope (%)	0.1

N/A	Ramp inside XWalk1?	N/A
			N/A	Road Slope (%)	N/A
			N/A	Road X Slope (%)	N/A
			N/A	Any Obstructions?	N/A
Total Cost:		\$ 1850.00		Obstruction Type	
			N/A		N/A
			Yes	Surface Condition? (G/P)	Good
