Access Compliance Report Public Rights-of-Way (Curb Ramps)

Intersection ID: 17049 Main Street: HAMPTON_AV Cross Street: HANSON_DR Location: NE

ADA ID: BEFD16D7AA19 Ramp Type: Directional1 Initial Pass/Fail: Fail Overall Compliance: No Severity Score: 13.75

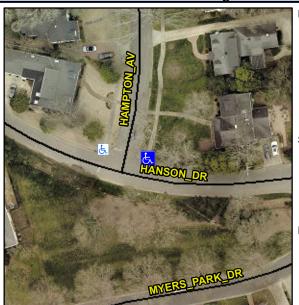
1.00	•		•	Yes	Ramp Width (in)	52.5	N/A	Grade Break Slope (%)	0.0
ĺ				No	Ramp Slope (%)	10.0	N/A	Grade Break XSlope (%)	0.0
				No	Ramp XSlope (%)	2.6			
				N/A	Flare Type LT	N/A	N/A	Flare Type RT	N/A
ğ				N/A	Flare Slope LT (%)	N/A	N/A	Flare Slope RT (%)	0.0
Canal C	Surveyor Notes:			N/A	Flare Traversable LT?	N/A	N/A	Flare Traversable RT?	N/A
1	N/A			N/A	Landing Length (in)	0.0	N/A	DWS Provided?	N/A
0				N/A	Landing Width (in)	0.0	N/A	DWS Contrast?	N/A
				N/A	Landing Slope (%)	0.0	N/A	DWS Length (in)	N/A
100				N/A	Landing X Slope (%)	0.0	N/A	DWS Full Width?	N/A
12	PROW/ADA:			N/A	Landing Curb? (Y/N)	N/A	N/A	DWS Offset LT (in)	N/A
STATE OF	R304.2.2, R304.5.3			N/A	Shared Landing?	N/A	N/A	DWS Offset RT (in)	N/A
	·			N/A	Gutter Ponding?	0.0	N/A	Gutter Slope (%)	N/A
				N/A	Gutter Lip Ht (in)	0.0	N/A	Gutter X Slope (%)	N/A

-				N/A	Painted X Walk1?	No		Road Slope (%)	2.8
					X Walk 1 Direction	To S		Road X Slope (%)	1.1
					X Walk 1 Width (in)	N/A	l	Clear Space?	N/A
					X Walk 1 Slope (%)	2.8	N/A	Clear Space to XWalk (in)	N/A
					X Walk 1 X Slope (%)	1.1	N/A	Storm Grate/Utility Hazard?	N/A
				N/A	Ramp inside XWalk1?	N/A		Storm Grate/Utility Type	
				N/A	Any Obstructions?	N/A			N/A
	Total Cost:	\$	1600.00		Obstruction Type		Yes	Surface Condition? (G/P)	Good
						N/A	N/A	Curb Slope (%)	7.8

D/Possible Solution			Field Measurements/Component Compliance						
No.	Possible Solutions:			Comp	liance Description	Data	Comp	liance Description	Data
ä	Remove & Replace Entire	Ram	ıp.	N/A	Ramp Length (in)	56.0	N/A	Grade Break?	N/A
