Access Compliance Report

Public Rights-of-Way

(Curb Ramps)

Intersection ID: 8714	Main Street: LASALLE_ST	Cross Street: CELIA_AV	Location:	SW
ADA ID: BF0B62C6D999	Ramp Type: Perp	Initial Pass/Fail: Fail	Overall Compliance: No	Severity Score: 25
Codes/Mitigation Info/Possible Solution		Field Measurements/Component Compliance

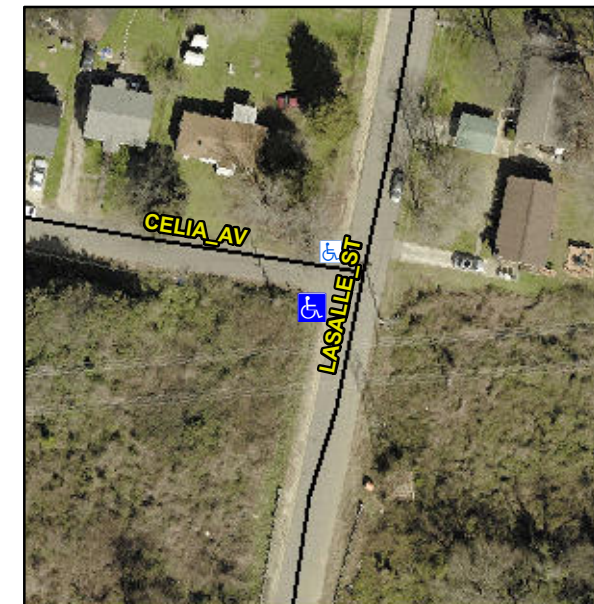
Not Found, R304.5.3

Compliance	Description	Data	Compliance	Description	Data
N/A	Ramp Length (in)	55.5	Yes	Ramp Slope (%)	6.5
Yes	Ramp Width (in)	52.0	No	Ramp XSlope (%)	7.1
N/A	Flare Type LT	N/A	N/A	Flare Type RT	N/A
N/A	Flare Slope LT (%)	N/A	N/A	Flare Slope RT (%)	N/A
N/A	Flare Traversable LT?	N/A	N/A	Flare Traversable RT?	N/A
N/A	Landing Length (in)	N/A	N/A	DWS Provided?	N/A
N/A	Landing Width (in)	N/A	N/A	DWS Contrast?	N/A
N/A	Landing Slope (%)	N/A	N/A	DWS Length (in)	N/A
N/A	Landing X Slope (%)	N/A	N/A	DWS Full Width?	N/A
N/A	Landing Curb? (Y/N)	N/A	N/A	DWS Offset (in)	N/A
N/A	Shared Landing?	N/A			
N/A	Gutter Ponding?	N/A	N/A	Gutter Slope (%)	N/A
N/A	Gutter Lip Ht (in)	N/A	N/A	Gutter X Slope (%)	N/A
N/A	Painted X Walk1?	No	N/A	Painted X Walk2?	N/A
	X Walk 1 Direction	To NE		X Walk 2 Direction	N/A
N/A	X Walk 1 Width (in)	N/A	N/A	X Walk 2 Width (in)	N/A
	X Walk 1 Slope (%)	3.0		X Walk 2 Slope (%)	N/A
	X Walk 1 X Slope (%)	4.1		X Walk 2 X Slope (%)	N/A

N/A	Ramp inside XWalk1?	N/A	N/A	Ramp inside XWalk2?	N/A
	Road Slope (%)	N/A	N/A	Clear Space?	N/A
	Road X Slope (%)	N/A	N/A	Clear Space to XWalk (in)	N/A
N/A	Any Obstructions?	N/A	N/A	Storm Grate/Utility Hazard?	N/A
	Obstruction Type			Storm Grate/Utility Type	
		N/A			N/A
			Yes	Surface Condition? (G/P)	Good

Possible Solutions:

Remove & Replace Entire Ramp.

Total Cost: \$ 1850.00
