Access Compliance Report Public Rights-of-Way (Curb Ramps)

Intersection ID: 20357 Main Street: CISCAYNE_PL **Cross Street: MEDEARIS_DR** Location: Ε **Severity Score:** ADA ID: BF13A858D3B4 Ramp Type: PerpDiag Initial Pass/Fail: Fail **Overall Compliance: No** 22.5

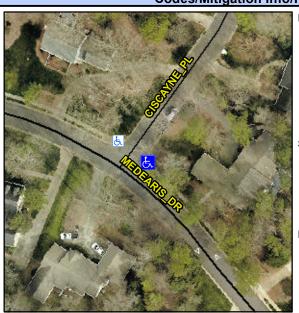
Field Measurements/Component Compliance							
Compliance Description		Data	Comp	oliance Description	Data		
N/A	Ramp Length (in)	57.0	No	Ramp Slope (%)	9.9		
No	Ramp Width (in)	37.0	No	Ramp XSlope (%)	2.1		
N/A	Flare Type LT	N/A	N/A	Flare Type RT	N/A		
N/A	Flare Slope LT (%)	N/A	N/A	Flare Slope RT (%)	N/A		
N/A	Flare Traversable LT?	N/A	N/A	Flare Traversable RT?	N/A		
N/A	Landing Length (in)	N/A	N/A	DWS Provided?	N/A		
N/A	Landing Width (in)	N/A	N/A	DWS Contrast?	N/A		
N/A	Landing Slope (%)	N/A	N/A	DWS Length (in)	N/A		
N/A	Landing X Slope (%)	N/A	N/A	DWS Full Width?	N/A		
N/A	Landing Curb? (Y/N)	N/A	N/A	DWS Offset (in)	N/A		
N/A	Shared Landing?	N/A					
N/A	Gutter Ponding?	N/A	N/A	Gutter Slope (%)	N/A		
N/A	Gutter Lip Ht (in)	N/A	N/A	Gutter X Slope (%)	N/A		
N/A	Painted X Walk1?	No	N/A	Painted X Walk2?	No		
	X Walk 1 Direction	To NW		X Walk 2 Direction	To SW		
N/A	X Walk 1 Width (in)	N/A	N/A	X Walk 2 Width (in)	N/A

X Walk 1 Slope (%)	2.3		X Walk 2 Slope (%)	4.2		
	X Walk 1 X Slope (%)	2.1		X Walk 2 X Slope (%)	0.4		
N/A	Ramp inside XWalk1?	N/A	N/A	Ramp inside XWalk2?	N/A		
	Road Slope (%)	2.3	N/A	Clear Space?	N/A		
	Road X Slope (%)	3.0	N/A	Clear Space to XWalk (in)	N/A		
N/A	Any Obstructions?	N/A	N/A	Storm Grate/Utility Hazard?	N/A		
	Obstruction Type			Storm Grate/Utility Type			
		N/A			N/A		
			Yes	Surface Condition? (G/P)	Good

OSSIDIE SOIGLION	
Possible Solutions:	
Remove & Replace Curb Ramp With	1
Two New Directional Ramps or	1
Equivalent.	1
	ı
	1
	1
Surveyor Notes:	ı
N/A	ı
	ı
	ı
	ı
PROW/ADA:	ı
R304.5.1, R304.2.2, R304.5.3	1
	1
	1

Total Cost: 3200.00
