Access Compliance Report

Public Rights-of-Way

(Curb Ramps)

Intersection ID: 12721	Main Street: S_CHURCH_ST	Cross Street: W_HILL_ST	Location: W
ADA ID: BF143C9C300D	Ramp Type: Perp	Initial Pass/Fail: Fail	Overall Compliance: No
Severity Score: 22.5			
Codes/Mitigation Info/Possible Solution		Field Measurements/Component Compliance

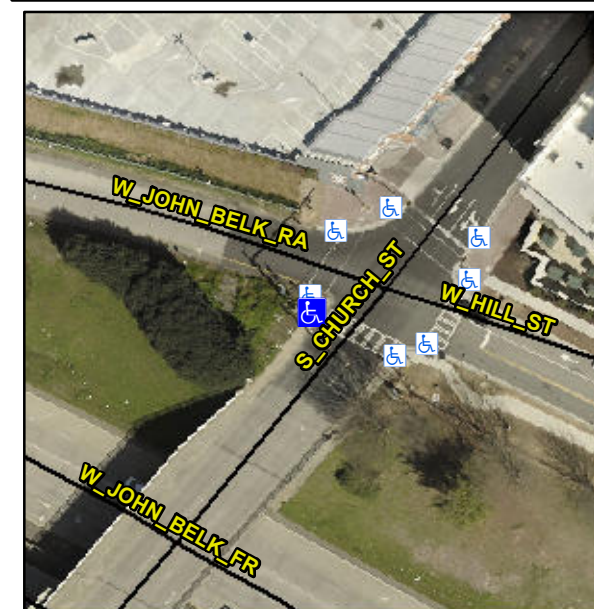
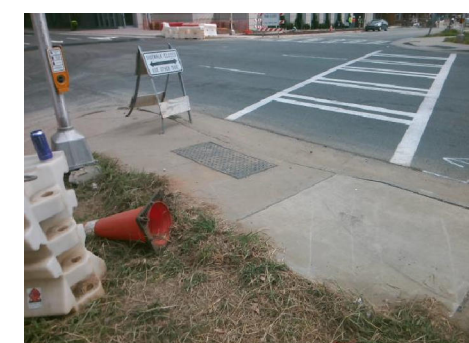
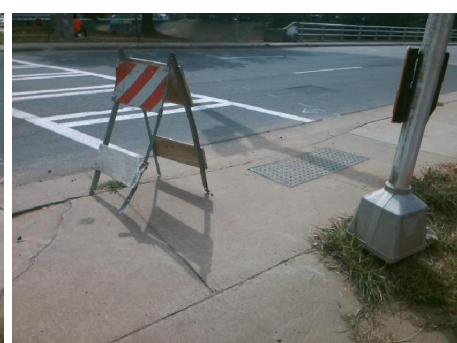
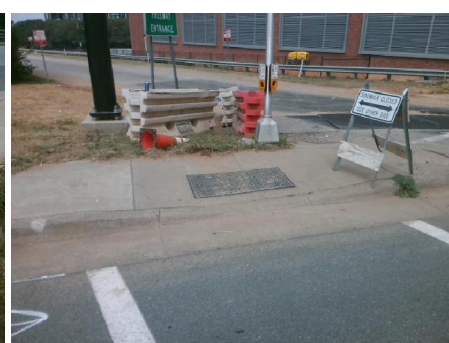
Not Found, R304.5.1, R304.2.2, R304.5.3

Compliance	Description	Data	Compliance	Description	Data
N/A	Ramp Length (in)	60.0	No	Ramp Slope (%)	9.1
No	Ramp Width (in)	45.0	No	Ramp XSlope (%)	2.1
N/A	Flare Type LT	N/A	N/A	Flare Type RT	N/A
N/A	Flare Slope LT (%)	N/A	N/A	Flare Slope RT (%)	N/A
N/A	Flare Traversable LT?	N/A	N/A	Flare Traversable RT?	N/A
N/A	Landing Length (in)	N/A	N/A	DWS Provided?	N/A
N/A	Landing Width (in)	N/A	N/A	DWS Contrast?	N/A
N/A	Landing Slope (%)	N/A	N/A	DWS Length (in)	N/A
N/A	Landing X Slope (%)	N/A	N/A	DWS Full Width?	N/A
N/A	Landing Curb? (Y/N)	N/A	N/A	DWS Offset (in)	N/A
N/A	Shared Landing?	N/A			
N/A	Gutter Ponding?	N/A	N/A	Gutter Slope (%)	N/A
N/A	Gutter Lip Ht (in)	N/A	N/A	Gutter X Slope (%)	N/A
N/A	Painted X Walk1?	Yes	N/A	Painted X Walk2?	N/A
	X Walk 1 Direction	To SE		X Walk 2 Direction	N/A
N/A	X Walk 1 Width (in)	100.0	N/A	X Walk 2 Width (in)	N/A
	X Walk 1 Slope (%)	3.5		X Walk 2 Slope (%)	N/A
	X Walk 1 X Slope (%)	1.0		X Walk 2 X Slope (%)	N/A

N/A	Ramp inside XWalk1?	Yes	N/A	Ramp inside XWalk2?	N/A
	Road Slope (%)	N/A	N/A	Clear Space?	N/A
	Road X Slope (%)	N/A	N/A	Clear Space to XWalk (in)	N/A
N/A	Any Obstructions?	N/A	N/A	Storm Grate/Utility Hazard?	N/A
	Obstruction Type			Storm Grate/Utility Type	
		N/A			N/A
		Yes		Surface Condition? (G/P)	Good

Possible Solutions:

Remove & Replace Entire Ramp.
