Access Compliance Report

Public Rights-of-Way

(Curb Ramps)

Intersection ID: 10011079	Main Street: PLAZA_WALK_DR	Cross Street: N/A	Location: SE
ADA ID: BF15AEBBCD6A	Ramp Type: Perp	Initial Pass/Fail: Fail	Overall Compliance: No
		Severity Score: 12.5

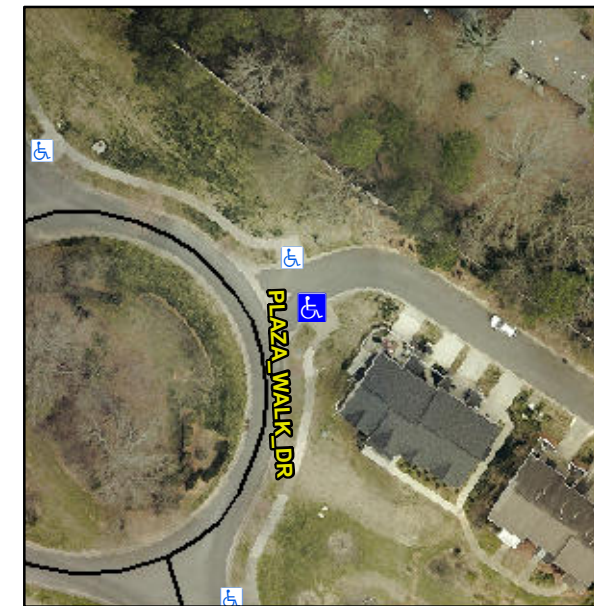
Compliance	Description	Data	Compliance	Description	Data
N/A	Ramp Length (in)	98.5	No	Ramp Slope (%)	8.6
Yes	Ramp Width (in)	48.0	Yes	Ramp XSlope (%)	0.7
N/A	Flare Type LT	N/A	N/A	Flare Type RT	N/A
N/A	Flare Slope LT (%)	N/A	N/A	Flare Slope RT (%)	N/A
N/A	Flare Traversable LT?	N/A	N/A	Flare Traversable RT?	N/A
N/A	Landing Length (in)	N/A	N/A	DWS Provided?	N/A
N/A	Landing Width (in)	N/A	N/A	DWS Contrast?	N/A
N/A	Landing Slope (%)	N/A	N/A	DWS Length (in)	N/A
N/A	Landing X Slope (%)	N/A	N/A	DWS Full Width?	N/A
N/A	Landing Curb? (Y/N)	N/A	N/A	DWS Offset (in)	N/A
N/A	Shared Landing?	N/A			
N/A	Gutter Ponding?	N/A	N/A	Gutter Slope (%)	N/A
N/A	Gutter Lip Ht (in)	N/A	N/A	Gutter X Slope (%)	N/A
N/A	Painted X Walk1?	No	N/A	Painted X Walk2?	N/A
	X Walk 1 Direction	To N		X Walk 2 Direction	N/A
N/A	X Walk 1 Width (in)	N/A	N/A	X Walk 2 Width (in)	N/A
	X Walk 1 Slope (%)	1.9		X Walk 2 Slope (%)	N/A
	X Walk 1 X Slope (%)	1.4		X Walk 2 X Slope (%)	N/A

N/A	Ramp inside XWalk1?	N/A	N/A	Ramp inside XWalk2?	N/A
	Road Slope (%)	N/A	N/A	Clear Space?	N/A
	Road X Slope (%)	N/A	N/A	Clear Space to XWalk (in)	N/A
N/A	Any Obstructions?	N/A	N/A	Storm Grate/Utility Hazard?	N/A
	Obstruction Type			Storm Grate/Utility Type	
		N/A			N/A
			Yes	Surface Condition? (G/P)	Good

Possible Solutions:

Remove & Replace Entire Ramp.

PROW/ADA:

R304.2.2

Total Cost:

\$ 1850.00
