Access Compliance Report

Public Rights-of-Way (Curb Ramps)

Intersection ID: 27093	Main Street: MCKEE_RD	Cross Street: KNOX_AV	Location: SE
ADA ID: BF181253E8A3	Ramp Type: Directional1	Initial Pass/Fail: Fail	Overall Compliance: No
Severity Score: 1.25			
Codes/Mitigation Info/Possible Solution		Field Measurements/Component Compliance

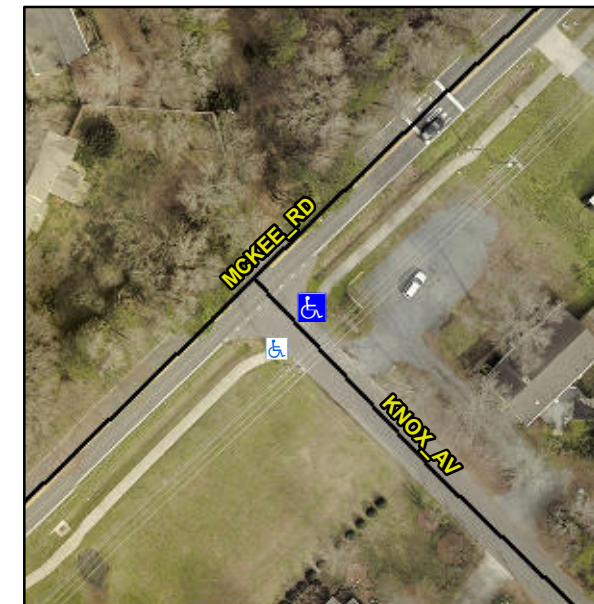
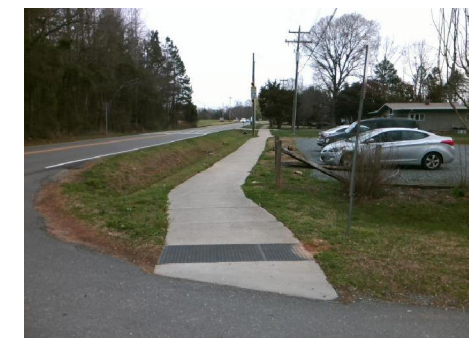
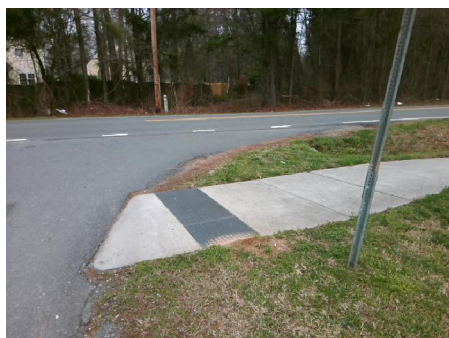
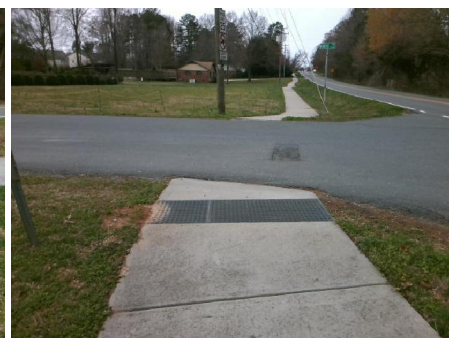
Compliance	Description	Data	Compliance	Description	Data
N/A	Ramp Length (in)	39.0	N/A	Grade Break?	N/A
Yes	Ramp Width (in)	52.0	N/A	Grade Break Slope (%)	0.0
Yes	Ramp Slope (%)	0.9	N/A	Grade Break XSlope (%)	0.0
No	Ramp XSlope (%)	3.1			
N/A	Flare Type LT	N/A	N/A	Flare Type RT	N/A
N/A	Flare Slope LT (%)	N/A	N/A	Flare Slope RT (%)	0.0
N/A	Flare Traversable LT?	N/A	N/A	Flare Traversable RT?	N/A
N/A	Landing Length (in)	0.0	N/A	DWS Provided?	N/A
N/A	Landing Width (in)	0.0	N/A	DWS Contrast?	N/A
N/A	Landing Slope (%)	0.0	N/A	DWS Length (in)	N/A
N/A	Landing X Slope (%)	0.0	N/A	DWS Full Width?	N/A
N/A	Landing Curb? (Y/N)	N/A	N/A	DWS Offset LT (in)	N/A
N/A	Shared Landing?	N/A	N/A	DWS Offset RT (in)	N/A
N/A	Gutter Ponding?	0.0	N/A	Gutter Slope (%)	N/A
N/A	Gutter Lip Ht (in)	0.0	N/A	Gutter X Slope (%)	N/A
N/A	Painted X Walk1?	No		Road Slope (%)	0.9
	X Walk 1 Direction	To SW		Road X Slope (%)	3.5
	X Walk 1 Width (in)	N/A		Clear Space?	N/A

X Walk 1 Slope (%)	0.9	N/A	Clear Space to XWalk (in)	N/A
	X Walk 1 X Slope (%)	3.5	N/A	Storm Grate/Utility Hazard?	N/A
N/A	Ramp inside XWalk1?	N/A		Storm Grate/Utility Type	
N/A	Any Obstructions?	N/A			N/A
	Obstruction Type		Yes	Surface Condition? (G/P)	Good
			N/A	Curb Slope (%)	3.7

Remove & Replace Entire Ramp.
