Access Compliance Report Public Rights-of-Way (Curb Ramps)

Intersection ID: 50579 Main Street: GREAT LAUREL RD **Cross Street: PAPER TREE RD** Location: NE **Overall Compliance: No ADA ID: BF2042734ABB** Ramp Type: Perp Initial Pass/Fail: Fail Severity Score: 21.25

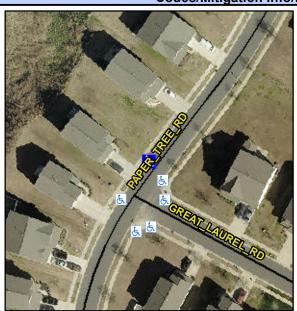
No N/A Ramp Length (in) 47.5 Ramp Slope (%) Yes Ramp XSlope (%) No Ramp Width (in) 47.0 N/A N/A Flare Type LT N/A Flare Type RT N/A N/A N/A Flare Slope RT (%) Flare Slope LT (%) N/A Flare Traversable LT? N/A N/A Flare Traversable RT? N/A N/A N/A **DWS Provided?** Landing Length (in) N/A Landing Width (in) N/A N/A **DWS Contrast?** N/A N/A N/A Landing Slope (%) DWS Length (in) N/A Landing X Slope (%) N/A N/A DWS Full Width? N/A Landing Curb? (Y/N) N/A N/A DWS Offset (in) N/A N/A Shared Landing? N/A **Gutter Ponding?** N/A N/A Gutter Slope (%) N/A Gutter Lip Ht (in) N/A N/A Gutter X Slope (%) N/A Painted X Walk1? No N/A Painted X Walk2? X Walk 1 Direction To E X Walk 2 Direction N/A N/A X Walk 1 Width (in) X Walk 2 Width (in) X Walk 1 Slope (%) X Walk 2 Slope (%) 3.1 X Walk 1 X Slope (%) 0.7 X Walk 2 X Slope (%) N/A N/A N/A Ramp inside XWalk2? Ramp inside XWalk1? Road Slope (%) N/A N/A Clear Space? N/A Road X Slope (%) N/A Clear Space to XWalk (in) N/A N/A Any Obstructions? N/A Storm Grate/Utility Hazard? **Obstruction Type** Storm Grate/Utility Type

Possible Solutions: Remove & Replace Entire Ramp. Surveyor Notes: N/A PROW/ADA: Not Found, R304.5.1, R304.2.2
