Access Compliance Report

Public Rights-of-Way

(Curb Ramps)

Intersection ID: 21408	Main Street: STARLITE_PL	Cross Street: WOODSTREAM_DR	Location: SW
ADA ID: BF2B36DF21FC	Ramp Type: PerpDiag	Initial Pass/Fail: Fail	Overall Compliance: No
			Severity Score: 13.75

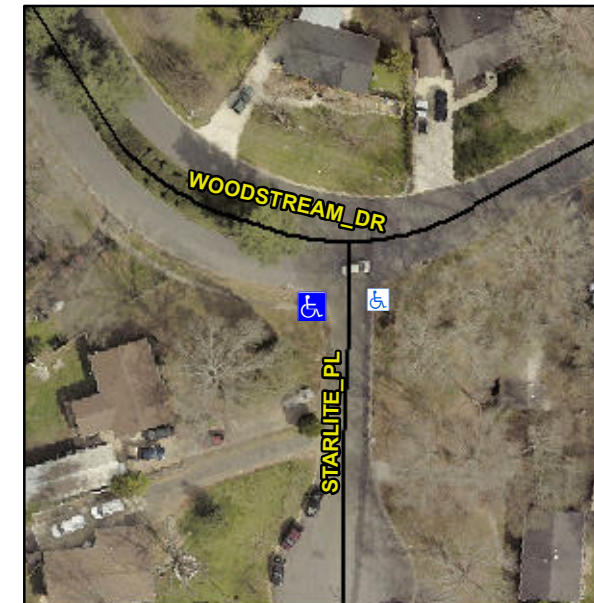
Not Found, R304.2.2, R304.5.3

Compliance	Description	Data	Compliance	Description	Data
N/A	Ramp Length (in)	92.0	No	Ramp Slope (%)	11.5
Yes	Ramp Width (in)	50.0	No	Ramp XSlope (%)	2.6
N/A	Flare Type LT	N/A	N/A	Flare Type RT	N/A
N/A	Flare Slope LT (%)	N/A	N/A	Flare Slope RT (%)	N/A
N/A	Flare Traversable LT?	N/A	N/A	Flare Traversable RT?	N/A
N/A	Landing Length (in)	N/A	N/A	DWS Provided?	N/A
N/A	Landing Width (in)	N/A	N/A	DWS Contrast?	N/A
N/A	Landing Slope (%)	N/A	N/A	DWS Length (in)	N/A
N/A	Landing X Slope (%)	N/A	N/A	DWS Full Width?	N/A
N/A	Landing Curb? (Y/N)	N/A	N/A	DWS Offset (in)	N/A
N/A	Shared Landing?	N/A			
N/A	Gutter Ponding?	N/A	N/A	Gutter Slope (%)	N/A
N/A	Gutter Lip Ht (in)	N/A	N/A	Gutter X Slope (%)	N/A
N/A	Painted X Walk1?	No	N/A	Painted X Walk2?	No
	X Walk 1 Direction	To E		X Walk 2 Direction	To N
N/A	X Walk 1 Width (in)	N/A	N/A	X Walk 2 Width (in)	N/A
	X Walk 1 Slope (%)	0.9		X Walk 2 Slope (%)	4.3
	X Walk 1 X Slope (%)	0.2		X Walk 2 X Slope (%)	2.7

N/A	Ramp inside XWalk1?	N/A	N/A	Ramp inside XWalk2?	N/A
	Road Slope (%)	1.7	N/A	Clear Space?	N/A
	Road X Slope (%)	1.1	N/A	Clear Space to XWalk (in)	N/A
N/A	Any Obstructions?	N/A	N/A	Storm Grate/Utility Hazard?	N/A
	Obstruction Type			Storm Grate/Utility Type	
		N/A			N/A
			Yes	Surface Condition? (G/P)	Good

Remove & Replace Curb Ramp With Two New Directional Ramps or Equivalent.
